ISDT MZ Project Diary – Started 27th February 2010 – Updated November 2014

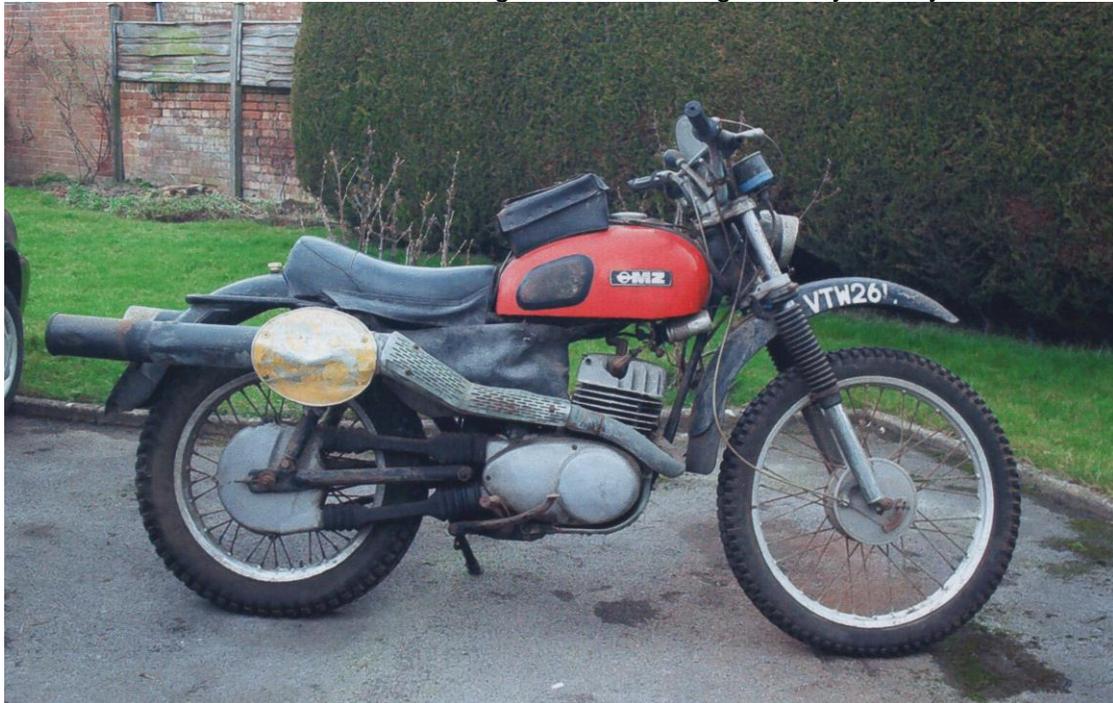
Just as I got stuck seriously into the ES250 combo project, I was offered a 1972 ISDT MZ,. This was something I could just not turn down so it had to be bought, even though the price was my beloved BMW R80st and another MZ. This sad looking beast is what I got for my money:

As always, pictures flatter and its a lot rougher than at first sight, but it is complete, almost totally original, and has been owned by the same person since 1975. The log book states that it was first registered in 1972 but no indication of how many previous owners. Speedo shows 14600kms, which is just over 9k miles.

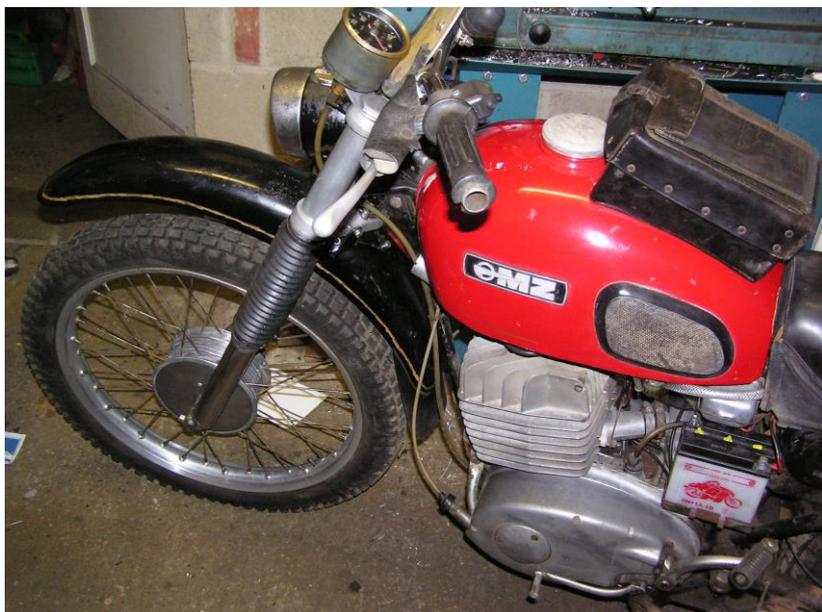
You can see the new gaiters, the wheel is pretty good now apart from the new spokes. The brake plate is sand cast so will never be really shiny. Headlamp rim is clean but needs replacing or re-chroming. Speedo has been moved to the other side as the thread in the fork crown was a bit better. Not sure how to pretty up the speedo, it's too big really and a smaller Simson type would look better. May try a TS type rubber surround. Tank was polished with Mer and I think will do, as I want to keep the patina of a used enduro bike. Tank bag is looking good after its re-stitching and dose of dubbin plus new map cover. I used

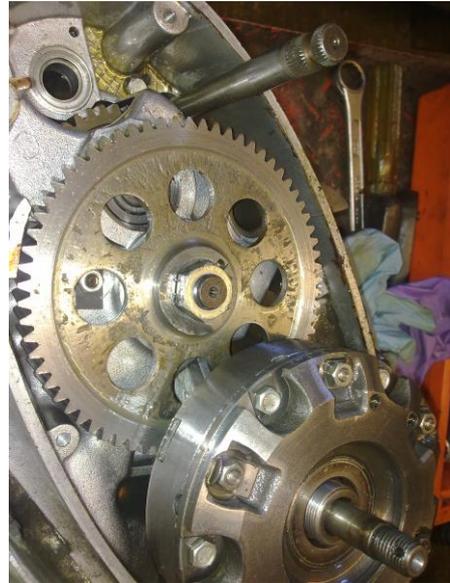
The drive gear itself is special to this engine being made of steel, the road engines use cast iron gears and this may go some way to explain the rattling noise I noted when I first restored the bike. The gear itself was very tight on the input shaft and my normal two-leg puller would not do the job so I had to make up a special tool to pull it off. The next obstacle was the clutch which made the puller really grunt under the strain before finally coming

loose. It was quite clear that the primary drive side had been worked on by a previous owner and I am beginning to feel that he was a gorilla. The other odd thing about the quite is that it was a perfectly standard 4-speed steel clutch of the type fitted to all 250 MZ road bikes of that era. I was under the impression that the ISDT engines had lightweight alloy clutches – something else on my list of things to check. The tapers on the crank and inside the clutch body seem fine though there was evidence that something had been used on the tapers to help adhesion.

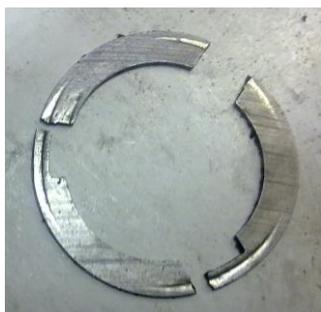
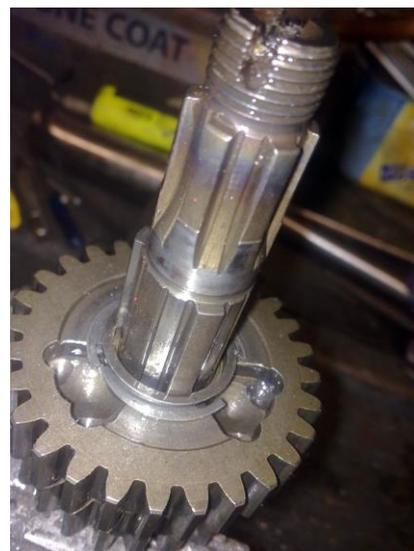
All the gears and selectors looked to be in perfect condition which was a relief but when I looked on the bench after tidying up I noticed some small pieces of metal. After some investigation I established that they are actually the remains of a shim or thrust washer that fits behind the circlip retaining second gear. They would have been held in place by the sliding part of 2nd gear but would also have been able to move outwards and block the gear selection when this happened. Exactly mirroring the problems I experienced when riding the bike and the reason for the strip.

Finding this was a relief as I half expected to find something far more serious like bent selector arms. You can see the wear marks in the washer in the first picture. The second picture shows where the washer came from (behind the circlip).

The next problem is to locate a replacement thrust washer. I checked the spares books for the other MZ 250 engines but the part number (19-46.068) does not appear in any of them. I also checked an old MZ dealers price list dating from 1996 but the part number is not listed – as far as I can see any part beginning 19-** is specific to the G5 motors as there this series does not figure anywhere else. I have contacted a couple of possible suppliers, one in the UK and one in Germany and posted a message on the G5 Forum. I am not overly optimistic about the latter as the group has been very quiet for years and I have only had one response to another query I posted and that was of limited help.

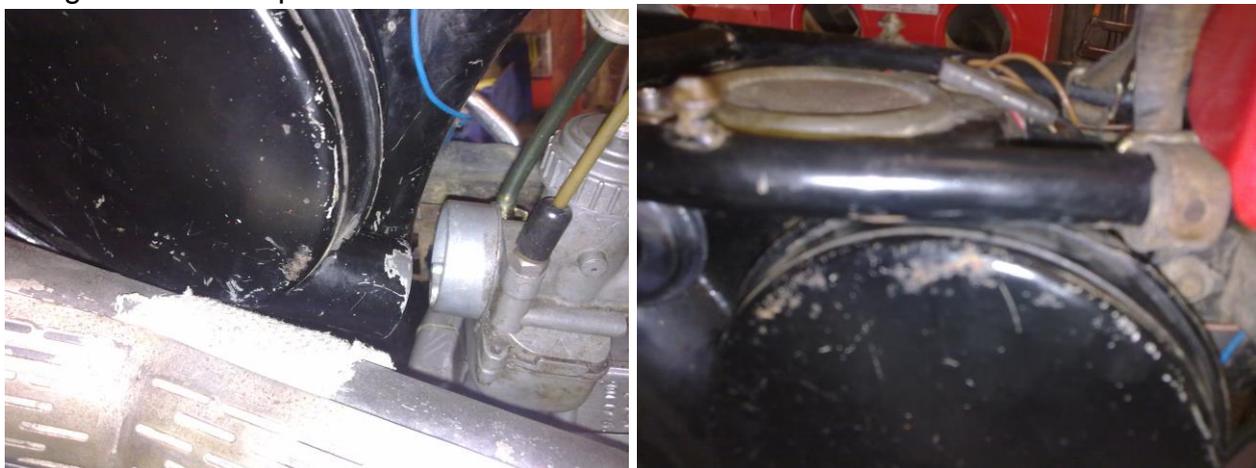
However before giving up for the day I did put a barrel on the crankcase fitted with the genuine ISDT manifold which I was given some time ago. The result was good in one way as the carb cleared the gearbox filler (though the rubber bung will need to be trimmed back) but the presentation of the carb does not line up with the tube on the air cleaner. I tried the manifold I made and this would line up better (but still not quite correct) but then the carb float bowl fouled the filler so that was not an option. On the ISDT motor the filler is on the other side and it is a perennial problem when trying to fit a 5spd MZ motor into a frame designed for the 4spd motors.

To make the air cleaner tube line up with the carb bell mouth I need to rotate the air cleaner box but the frame top tube limits the amount of movement. The obvious solution is some surgery on the air cleaner box to allow more movement. It is unlikely to affect performance and would not be seen as the fabric skirt hides this area but I am taking time out to think around the problem. This time it's nothing to do with the Supa5 motor as I would have exactly the same problem with the original ISDT motor.
