MZ Supa5 Gearbox Woes – A new Theory on the causes

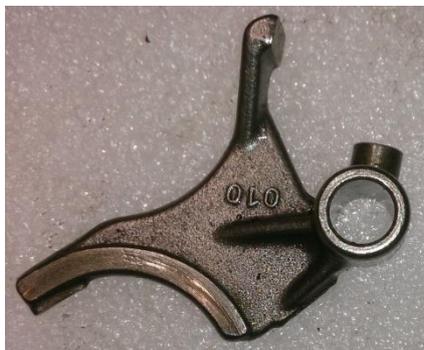
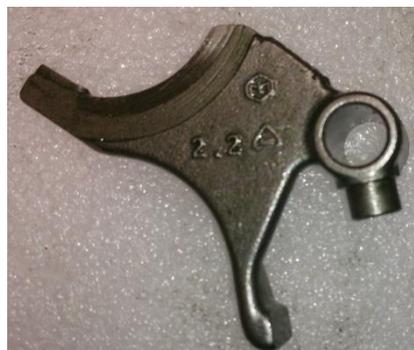
The engine stripped quite easily with no obvious problems, no swarf or broken bits in the bottom of the gear chamber anyway. The 010 selector was showing signs of wear but it was polished rather

than measureable. It was far from the point where it was blackened from excess heat and half its original thickness which is how they normally appear once the gear jumping problems become starts.

The selector drum projection measured 19.3mm which I would have said was well within the range of acceptability, the only other one I had available was 19.4mm and H&T Vol 2 mentions figures as low as 18.75mm.

What you can see in the drum picture above is that one edge of the projection is worn away, it should be flat. My guess is that this was caused by the violent jumping out of gear pushing the 010 selector into the drum and probably turning it sufficiently to turn the drum and deselect. The 1/3 slider gear had lost its undercuts on the 3rd gear side and is probably scrap after only 20 miles or so of use. I could not easily see or measure the state of the undercuts on 3rd gear but I imagine they will be in a similar state. The other odd thing was that the retaining circlip for 3rd gear was not in its groove so third gear could move away from second gear. However, since it would be pushed back into place when 3rd gear was selected I could not see that this by itself was the cause of jumping out of gear; though it could clearly generate other problems.

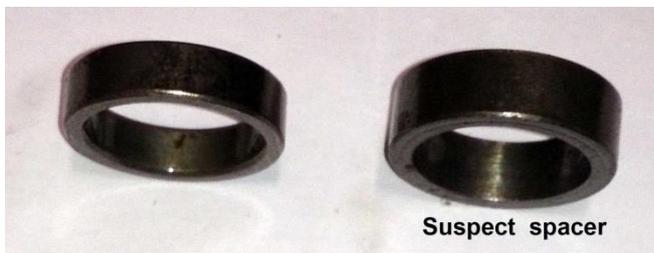
Other than that I could see nothing obvious wrong and my first thought was that the pattern parts I had used were rubbish. However, I decided to investigate further and made an interesting discovery, the spacer (distance piece in MZ terminology) between 2nd and 3rd gear was considerably wider at 8.6mm than the one in another MZ gear cluster I checked which was 7mm. I think that this is a home made item and goes back into the history of the gearbox problems with this engine.

Comparing the two gear clusters, my control set had quite a lot of slack around 3rd gear whereas the suspect cluster would barely allow the retaining circlip into its groove and indeed under use it was clearly coming out (see comment above).

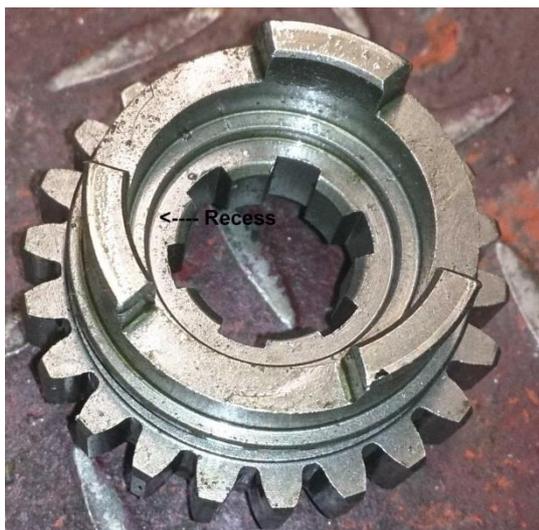
I have a sectioned set of Supa5 crankcases and when I assembled the suspect gear cluster in them it was very difficult to select 3rd gear, the wide spacer pushed 3rd gear so far forward that the slider gear was binding before it was fully engaged. Moreover 2nd and 3rd gear were tightly pressed together and not free to spin independently. You could see the pressure marks of this excessive contact on all the relevant parts.

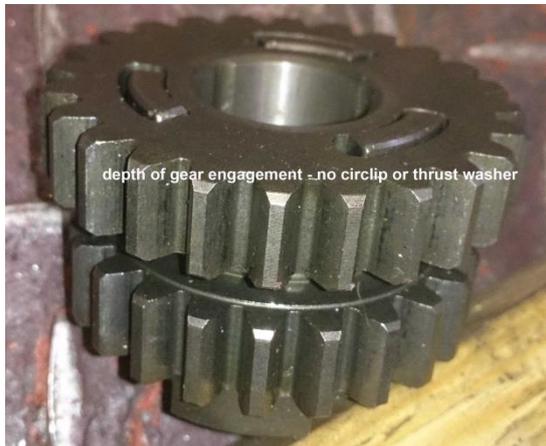
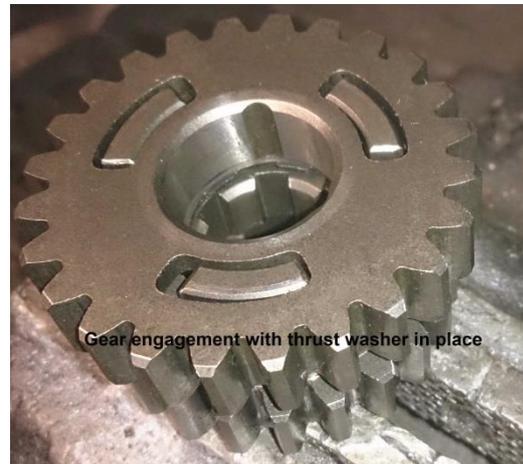
Initially I thought that this excessively wide spacer was the whole cause of the problem but the more I thought about it the more I became convinced that something else was involved. In theory increasing the size of the spacer pushes 3rd gear into engagement with the 1/3 slider gear so this should help meshing rather than causing jumping out of gear. Examination of all the parts established that full mating of the gears was actually limited by the movement of the 1/3 slider gear. On the bench with no circlip or thrust washer the gears would mesh very close together. The 1/3 slider gear has a recess and this is wide enough for the circlip but not quite wide enough for the thrust washer. (The depth of the recess is greater

than the combined thickness of the circlip & thrust washer – at least on the aftermarket gear I am testing). You can see in the next two pictures how the dogs protrude right through the gear when no washer is in place but do not protrude fully once it is used. In an assembled cluster the difference is

penetration is about 1mm; the sum of the thickness of the thrust washer plus the difference between the thickness of the circlip and the depth of recess.

My next move was to very gently grind the outer circumference of the thrust washer such that it would fit inside the 1/3 slider gear recess. I then reassembled the cluster and now have gears which will fully engage with a little slack to allow them to move comfortably into position. I had already slimmed down the distance spacer to 7mm, in hindsight I wish I had left it a little wider as with my thrust washer alteration, it could safely be at least 7.5mm.
