The BK350 Saga

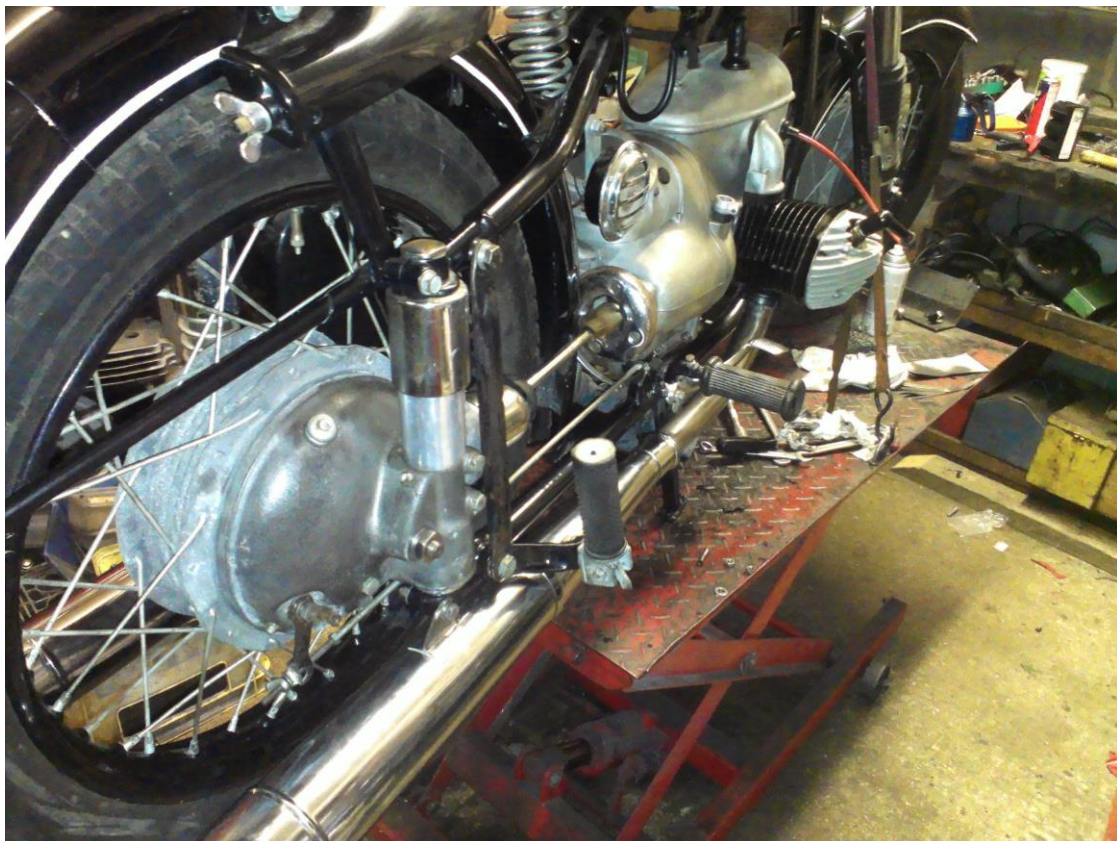
There was a lot of smoke coming from various places in the exhaust system and I doubt there were many baffles in the silencers as it was rather noisy. I decided it was time to fit my shiny new exhaust system but first I masked off the barrels and gave them a coat of black BBQ paint from a spray can. This hides the rust nicely for now. Later I will probably have the barrels sand blasted and powder coated black. Removing the old exhaust system was easy, most of the fittings were quite loose. My first attempt to fit a new pipe and silencer was very disappointing. On the off-side whichever combination of pipes and silencers I tried it

was simply impossible to get the system to align properly. I had more success with the near side and found a combination of pipe and silencer which aligned pretty well spot on. Out of interest, I tried the original off-side exhaust pipe with a new silencer and still no joy, the

pipe was too short and in any event it was pretty shoddy. More out of desperation than anything else, I tried the near side exhaust pipe and to my surprise it was a perfect fit with the new silencer. Moreover, this pipe was a stainless steel item which I was able to polish up quite well. At some time I will have to re-visit the off-side exhaust for now I have a pretty good looking system.

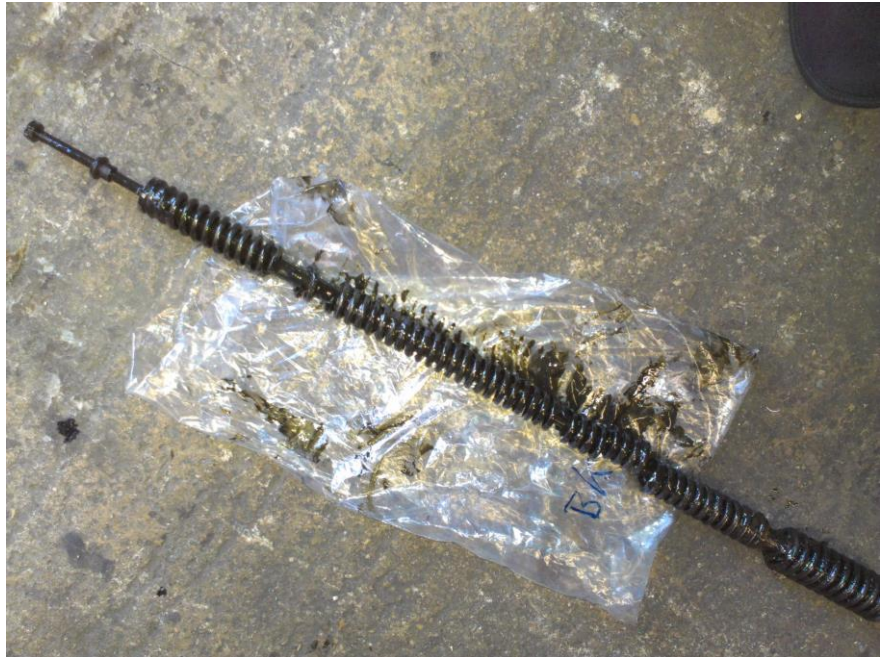
found that the main spring was broken into two parts. I removed both and reversed them in the holders so that the flatter ends were abutting and made up a special washer which sat between the two parts of the spring to prevent them coiling inside each other. This works quite well but does mean that there is nothing to stop the fork topping out on rebound.

Doing the bellows on the offside fork leg was even easier as I now knew how to do it. However, the spring on that side was in no less than seven pieces totally beyond repair and the bottom bush also had some slack. This probably accounted for the slight judder I noticed on braking so I will replace this as well. The bike will now be off the road until I can source a pair of springs and the bushes.

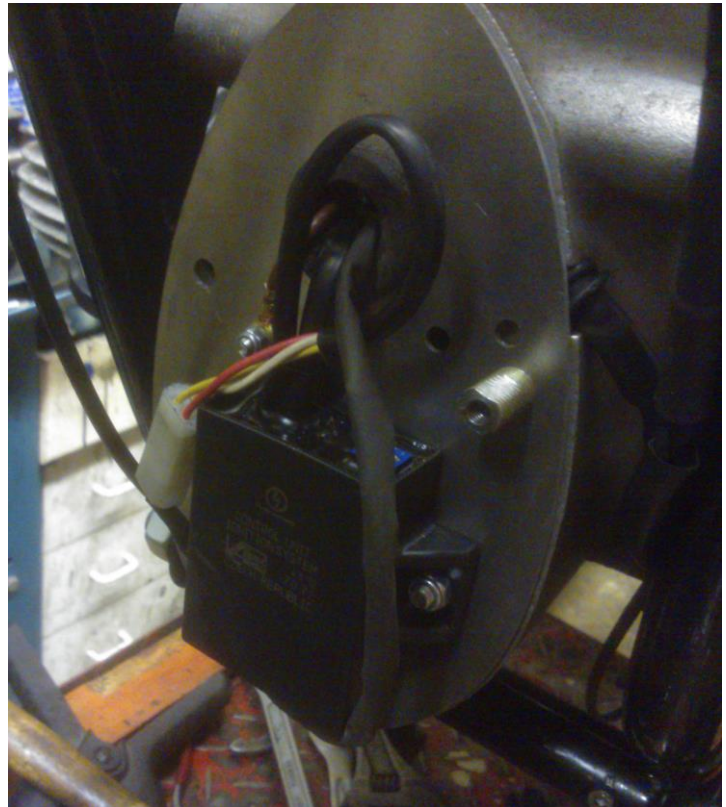
The main benefit of this change is that the engine-loom connections are now all outside and easy to disconnect without having to dismantle the front engine cover. While I was working in that area I revised the way the Powerdynamo plate holding the ignition a/r black box is mounted. As delivered this plate floats free so you have to try and locate it together with the outer cover and of course it just flops down when the outer cover is removed. I made up a 20mm

piece of rod internally threaded 6mm. This now screws down to a 6mm dowel in the crankcase and holds the plate firmly in position. I shortened the out fixing screw which now goes into the 20mm threaded rod. The picture probably makes more sense than the description.

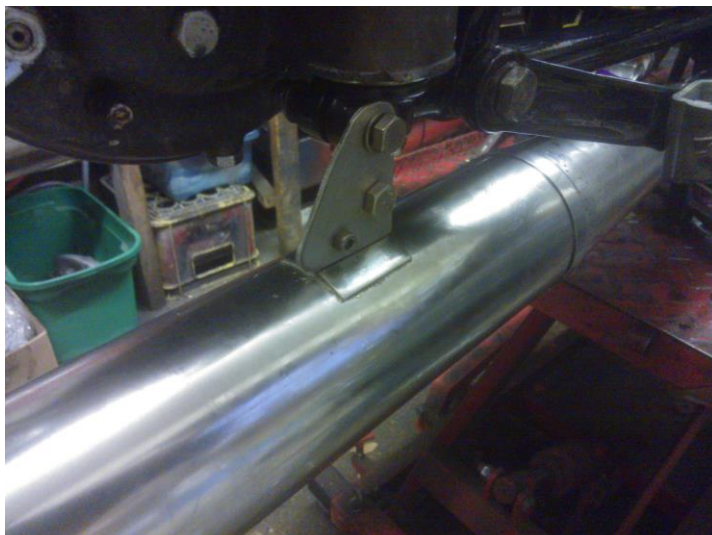
new parts. I was determined this time to use the complete new system but each time I offered it up the result was disappointing. The silencers are identical but the pipes do have a slightly differing bend but whichever side I put them on they did not look right. Eventually I got it all to line up with the mounting holes in the frame but when I looked from the rear the offside silencer was sitting

about 4 inches higher than the nearside. The problem seems to be with the pipes which are not quite the right bend but though the system is new I don't know from where it was purchased so I cannot take issue with the supplier. In the end I decided the safest thing to do was make up an extension plate for the offside silencer mounting which drops the silencer to the same level as the nearside. That way, to anyone following behind they will look level though if you look closely you can see that they slope towards the pipes at differing angles. Raising the nearside (which I would have preferred) was not an option as the silencer is already very close to the frame on this side. I even tried making up a thick gasket for the exhaust manifold to push the pipe down lower but this did not work and really left too little thread to make a secure fixing. I guess German after-market stuff is just as bad as the stuff we often get for British bikes.
