1937 AJS Model 37/12

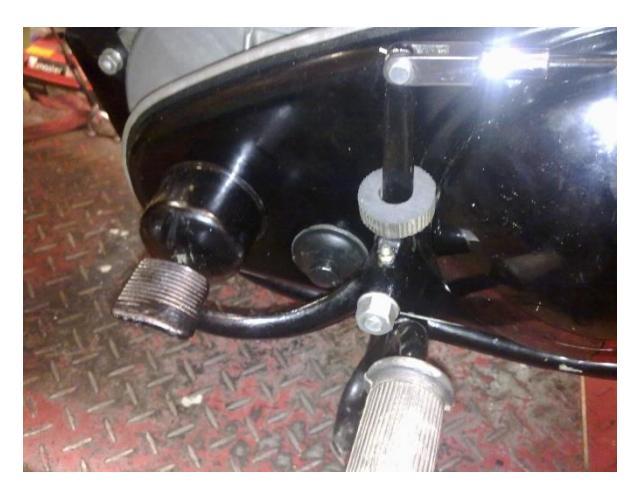
The enigma about the brake pedal stop was looked into. The brake pedal itself rotates ona shaft which is probably an extension of an engine fixing bolt and runs right through the

chaincase. Mine has nothing to limit its movement backwards except when it collides with the dome of the clutch cover. A thick rubber tube had been fitted which both limited the travel and stopped the pedal rubbing paint off the dome. My queries elecited a variety or responses including one which I thought initially the most sensible in that one owner of this model had a stop bracket welded to his chaincase. Seems most likely however that this was a later mod

(bodge?) and not correct. For 1937 only the spares book does specify a piece of rubber to fit on the brake pedal. No pictures so no one knows for sure the dimensions. It seems that bizarrely in my view that there is no adjustment at the brake pedal end and the piece of rubber specified is purely to stop paintwork damage should the pedal spring back to hard. Adjust is apparently done at the brake drum end by shimming the brakes shoes so that very little movement of the brake arm is needed to operate the brake. The position of the brake pedal is then set effectively by adjusting the position of the brake a arm on its splines and the brake rod length. The brake shoe springs seem to be the only thing pulling the brake off. As the brake actually works ok I have left it as is for now and will investigate further if there is a need or the wheel has to come out for some other reason

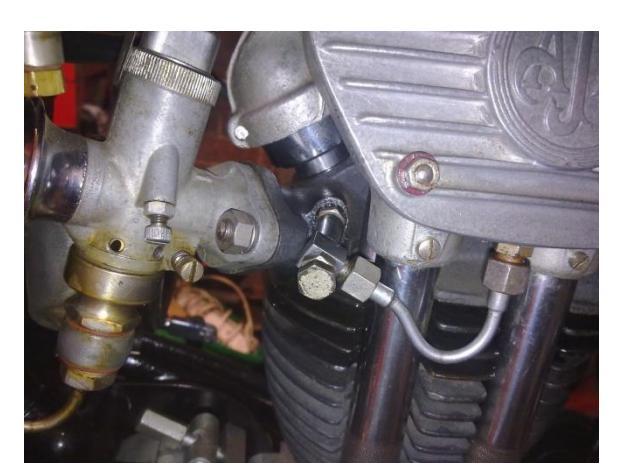
All the responses to my query about oil leakage from the decompressor shaft indicated that this was not a common problem and the cause might lay elsewhere. Excessive crankcase pressure caused by a breather problem was suggested and bearing in mind that the engine was smoking a little more than one might expect after a rebore, this seemed feasible. However, the vendor assured me that he had checked the breather when he rebuilt the engine and replaced the diaphragm so perhaps less likely. Access to the breather requires the entire drive side to be stripped. I decided to leave that as a last resort. One other area of investigation was the oil supply to the inlet valve which is a common feature on AMC machines. When I looked at this I found two issues. Firstly there is some complex plumbing to connect rocker box to the valve area and the assembly was not fully tightened at the

valve end. Closer inspection showed a considerable oil leak from here which had actually run along the fins and may well have finished up in the area of the decompressor. Tightening the nut required grinding down a spanner as it's virtually inaccessible. If this does not stop the leak I will have to fully strip the plumbing to fit a copper washer as none is evident. I also checked the setting of

the inlet oil feed valve and he may lie the cause of the smoking. The book states no more than half a turn out from closed whereas mine was set to probably 1 ½ to 2 turns. I stripped it out and the tapered screw etc all looked fine so it is now set to just under ½ a turn. Not yet run the engine long enough to prove my diagnosis and cure but hopeful.

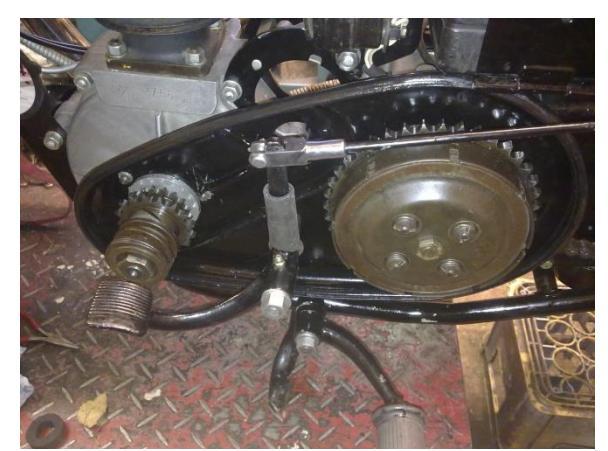
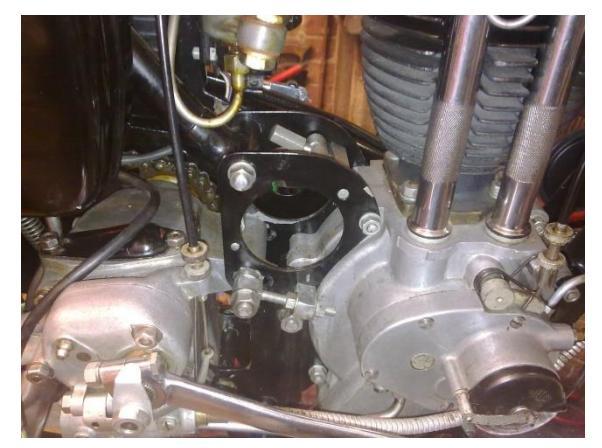
and primary chain all look in excellent condition and the cover does have one of the patent rubber oil seals developed by a Jampot club member. It was completely oil tight before removal, hope it remains so when

and only took ½ hour or so once I actually started. The drive chain has no split link so I had to find an extractor to get the sprocket of the spline but once this was done and the dynamo clamp was slackened it slid out easily. Pleasingly, the clutch, engine sprocket

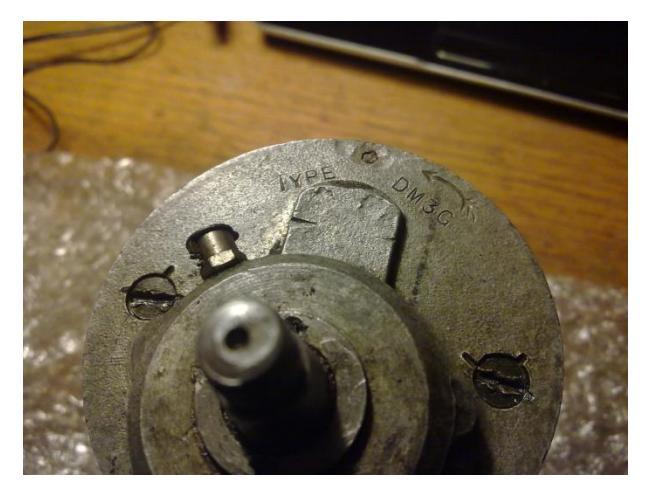
With the dynamo on the bench I repeated my previous tests and used the electric drill to drive it all with no positive result. Out of curiosity I connected up a rather tired 6v battery and bingo it did a very good impression of an electric motor. Though I had cracked it but further tests for dynamo functionality still gave no charge. Now totally stumped as I had

always thought that a dynamo that would work as an electric motor would normally charge ok. A friend has arranged for Ray Carter, the AJS guru and ace restorer to look at the dynamo for me so it's going to him on Wednesday. I did notice that the main drive bearing felt a bit rough so at the very least this will need replacing. I hope he can fix it and am intrigued to find out what is actually wrong. The dynamo does appear to be the original or identical

in type as it's stamped DM3G. In the bike it looked to be a long shaft type but now it's on the bench it is quite clear that it is the short shaft 36w model.

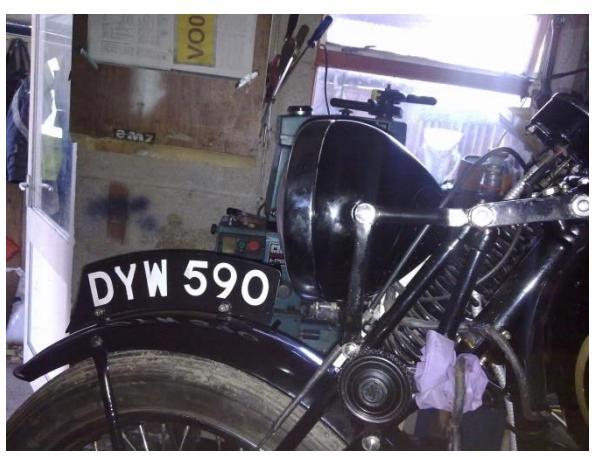
While I was in workshop mode I decided to have a look at the headlight mounting. Having studied various pictures it was clear that it sits far too low emphasising that it is also the wrong shape having too much of the shell forward of the fixing holes. In the box of bits

which came with the bike was a selection of headlamp brackets so I experimented with these and found using a shorter top bracket and a longer bottom one I could get the unit higher and closer to the fork much more like the 1937 catalogue picture. I only had one of each but there were enough oddments in the box to make up a second pair and after a bit or drilling and bending they were a good

match. The picture shows the result including the front number plate which now fits properly.

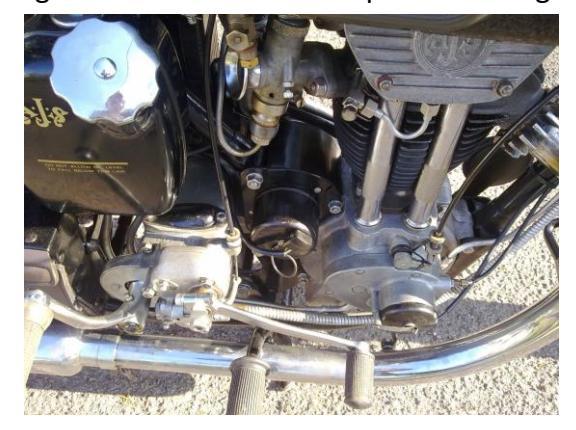
Quite a rewarding weekend. On the Saturday I talked to the people at Sprockets Unlimited and they were able to make me a 65 link chain by riveting in a half link so it only needs one spring link. I also ran into Ray Carter and arranged to lick up the dynamo on the Sunday. On Monday I was all set to finish the AJS and finally get a test ride. Fitting the dynamo was quickly done and it was connected up using the rather neat special plug. Engine started first kick and the ammeter stubbornly refused to show any sort of charge. To say I was disappointed was the understatement of the year. I ran some tests and sure enough a bulb glowed brightly when connected to earth across the F & D terminals. Visions of blown regulators or other horrors passed through my mind but then common sense prevailed and I

looked carefully at all the connections and the penny dropped. Ray had sensibly wired up the dynamo connection sockets so that they agreed with the embossed labels on the cover. The connection pins were wired up the opposite way. Turning the connector upside down immediately restored charging – huge relief. I have now swapped the wires in the connector so that it can be fitted correctly.
