Diary of the BMW/EMW R35 Project - Started September 2011

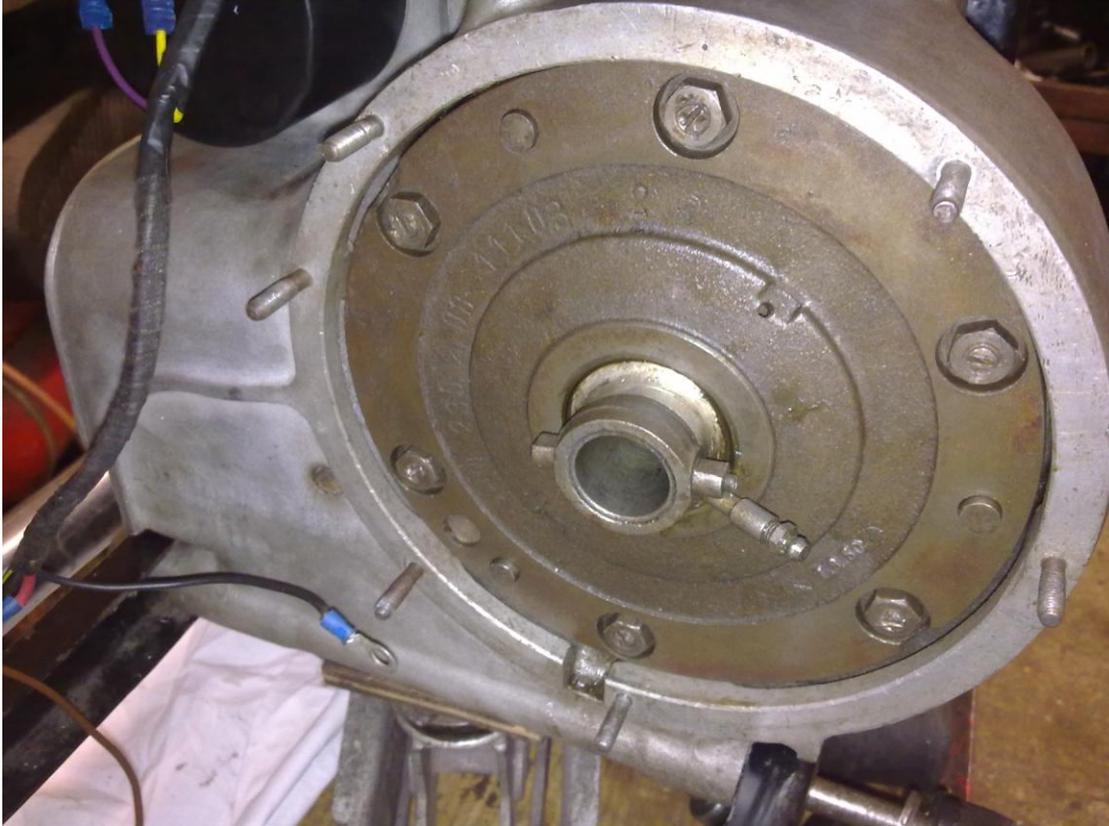
After an hours patient disassembly I finally managed to get the gearbox out of the bike to inspect the damage, I also removed the head and barrel so that I could check whether the crankshaft had moved. The damage seems to be limited to the bent and chewed clutch operating arm which can be seen in the picture above. Looking at the crankshaft through the top of the crankcase, the amount of clearance looked pretty much identical to what I had set originally. This did eliminate one fear that the multi row main bearing I had used was not suitable for the task. There was nothing else obviously wrong. After much head scratching the only thing I could conclude that the

problem was caused by the drive pins in the flywheel, which seemed to be sticking out much farther than was necessary. I did momentarily consider taking an angle grinder to them but common sense prevailed so I retrieved the extractor tool I made a couple of days ago and pulled the flywheel. The pins are a tight press fit in the flywheel and with the clutch assembled on the bench, it was obvious they only needed to protrude about 20mm. In fact two were about 26mm and the other was 25mm. Careful squeezing in the vice got them all down to 20mm without damaging

anything. This still leaves about 1.5mm for the pressure plate to move outwards which I think is plenty. You can see the result in the picture below:

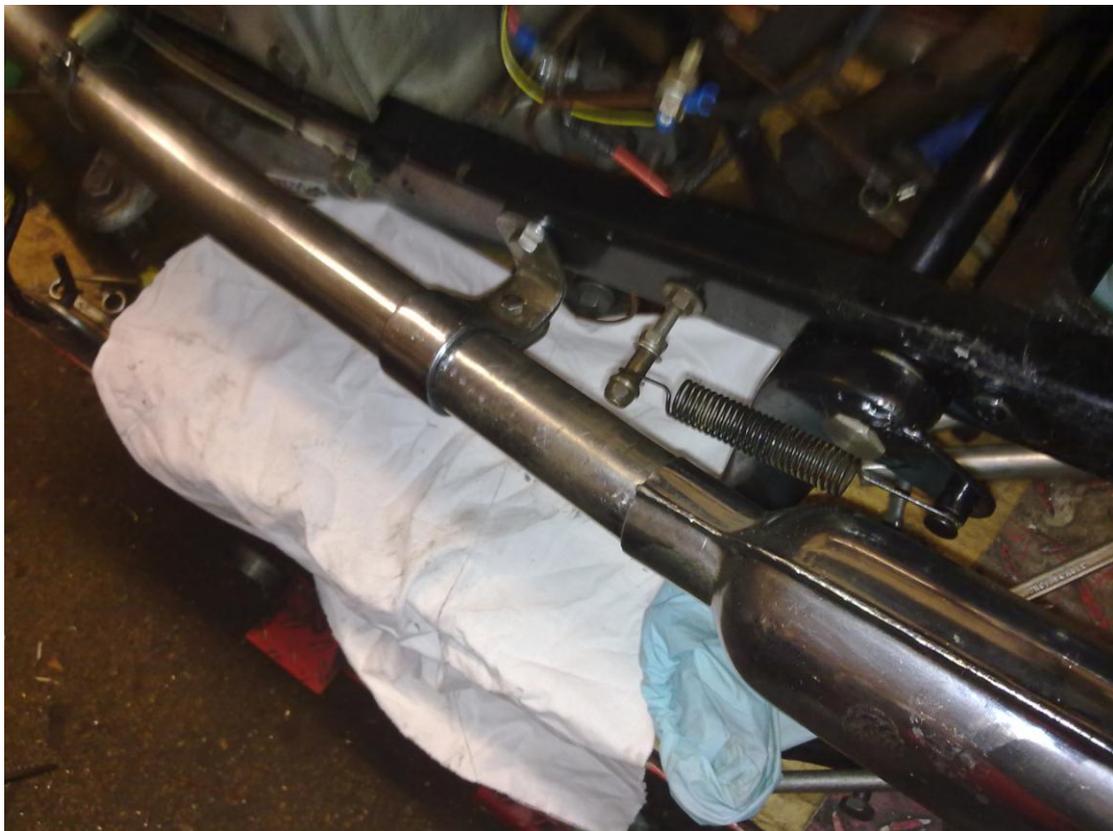
I have replaced the barrel and head on the engine as all seems well in that department. I made up a thinner head gasket in alloy and tried this in place of the very thick brass head gasket. The valves still cleared the piston so I have left the alloy gasket in place. Kicking the engine over I was able to see that oil was coming out of the crankcase feed pipe to the rockers so the pump is clearly working which was a relief. I also had another attempt at fitting the exhaust system having found another bracket that lined up with a convenient hole in the frame. To get the pipe to fit better in the silencer, I cut several short slots at the very end to allow the pipe to shrink slightly in size. This has worked well and the pipe/silencer joint is now very sound. Overall I am now happy with the alignment and security of the exhaust system. You can see the new clamp in the picture below.

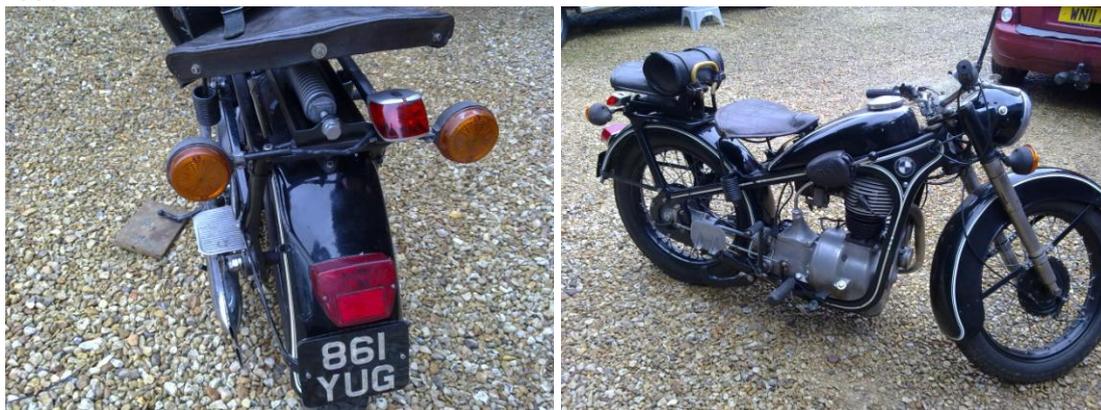
Well as always, it took longer than I expected, but I now have a set of ex MZ indicators working on the R35. A couple of pictures are included to show the end result.
