Project Diary – 1973 MZ ES250/2 – UOY76M – Started May 2018

Concluded - Tuesday 15th January 2019

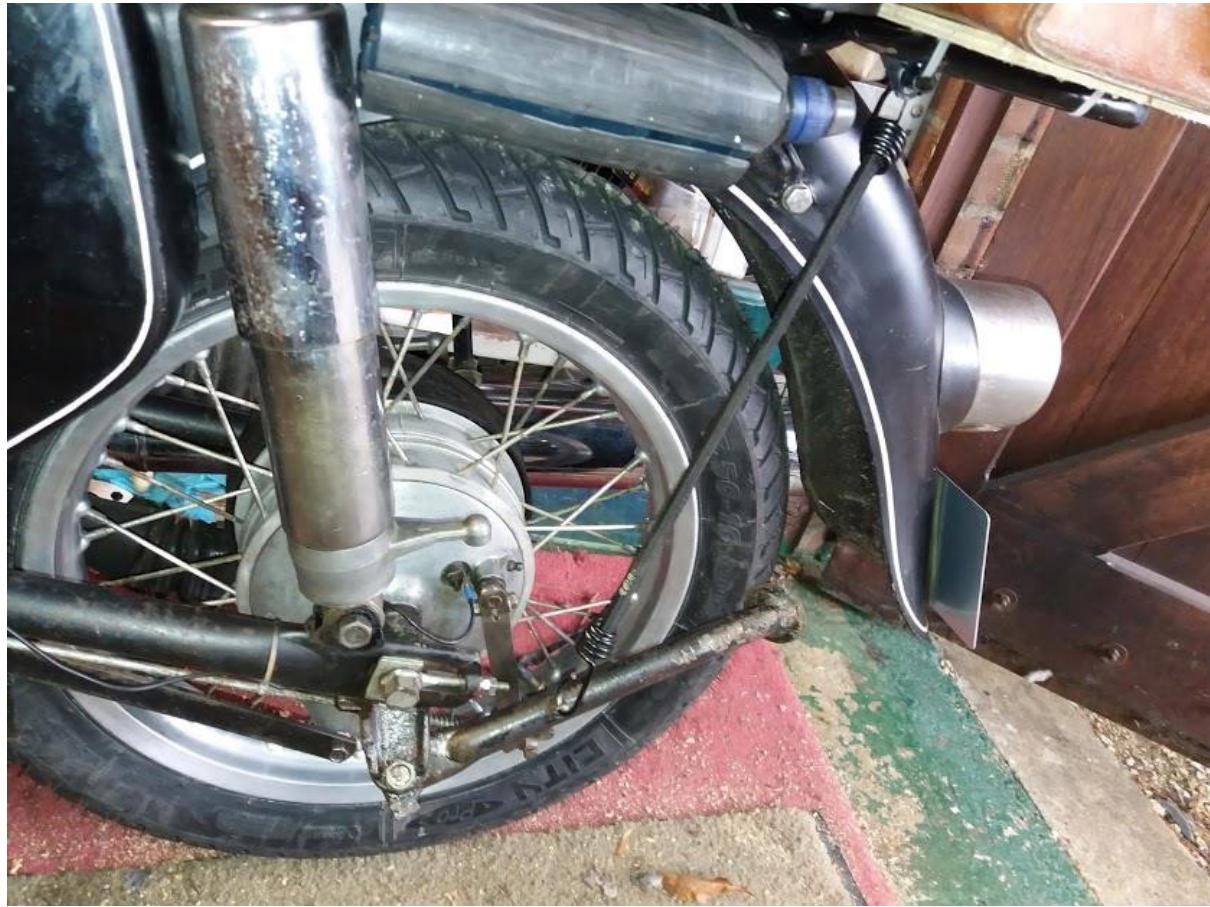
I continually forget to lift the rear stand on my MZs before pulling away. Sometimes I remember before the first LH bend and then perform that artistic movement beloved of all MZ owners trying to kick the stand up with my left leg whilst still riding the bike. All too often its that pogo stick effect as

you take a LH bend that reminds me. I have had my share of heart stopping moments and decided that if I cannot devise some sort of warning device it will have to be removed though its so useful I don't really want to do that.

Today I spent an hour or so with a selection of micro switches a stop light switches trying to wire in a warning light/buzzer or even better disable the power to the coil so the bike will not start if the stand was down. However, placing such a switch defeated me the location of the stand and the overall design of the s/arm simply did not make it feasible – to me anyway.

Then I had one of those eureka moments and came up with the solution in the picture. Simply and effective if a bit ugly and should be adaptable to all my other MZs. The bungee is only strong enough to pull the stand up when the bike is pulled upright. Anyway I will trial it for a few days to mke sure there are no hidden snags.
