Diary of the BMW/EMW R35 Project - Started September 2011

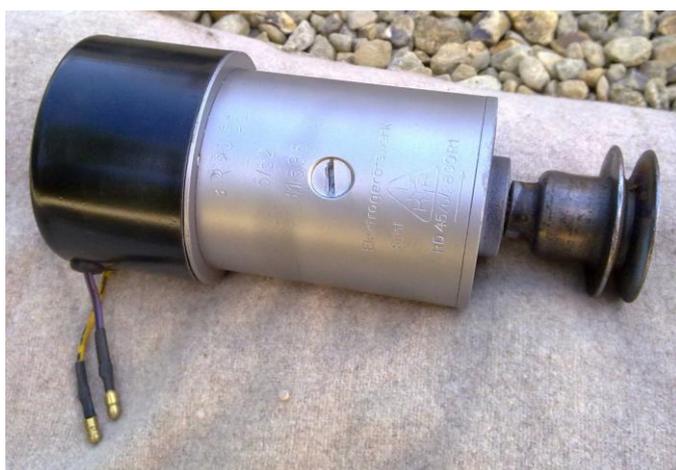
I removed the dynamo today and made up connectors so that it would be easier to remove next time. Under the cover the cut-out and dynamo look pristine with shiny commutator and new brushes so this looks promising. I did clean up and repaint the outside so that too now looks presentable. Closer investigation of the wobbly rear

wheel established that it was no more than a missing washer. Without it the nut bottomed on a shoulder of the wheel spindle. Would be nice if all problems were so easily solved. I also decided to remove the front wheel to check the state of the brake components. The linings were obviously new and there was only a little rust on the drum so it was all carefully re-assembled.

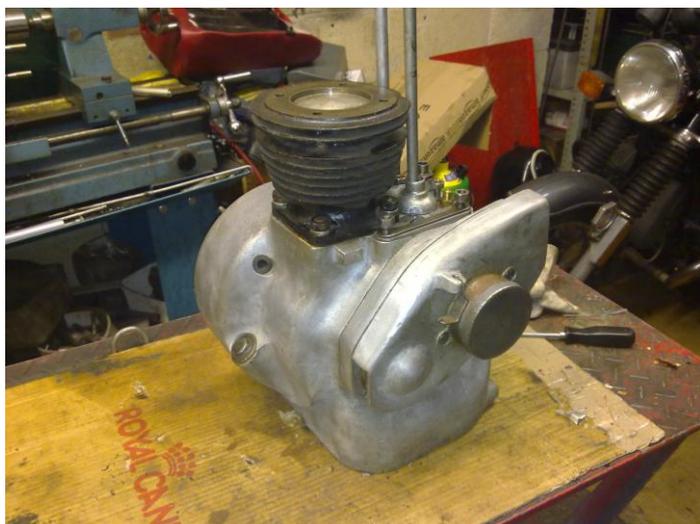
A nice new piston (R60 BMW I understand) and a re-sleeved barrel came with the bike so these were fitted after I had improvised a ring compressor out of a piece of thin strip steel and a couple of cable ties. This piston has three compression rings and two oil control rings.

Seems like a bit of overkill to me and if the engine feels stiff after running-in, I may remove one of more of these rings. Amazing to think that it took me a whole day to get this far on what is a very simple design. I guess it's always the same with an engine that someone else took apart and it will be a lot quicker and easier next time. Final check before packing up for the night and the engine still turns freely though a little more friction

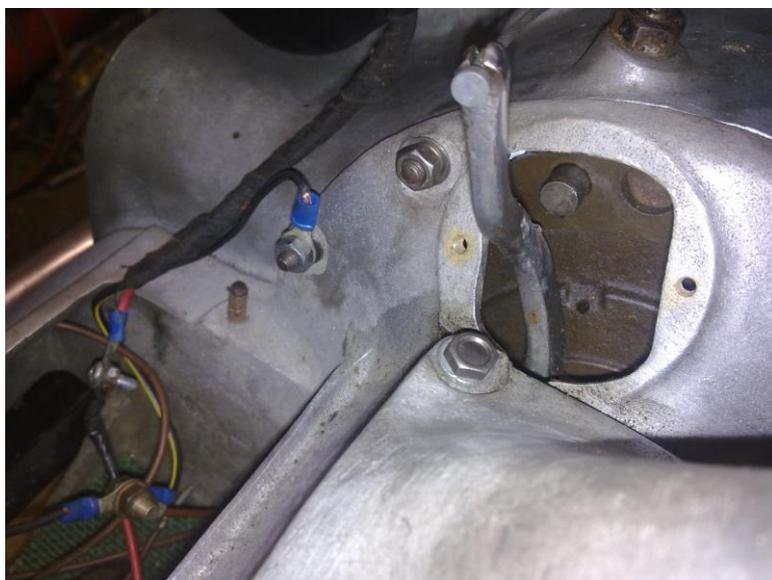
comeuppance. For no particular reason, I pulled in the clutch lever; there was a horrible graunching noise and the engine immediately stalled! Panic panic panic. Gently operating the kickstart gave no indication of problems so I turned the ignition back on, gave it a proper kick and the engine started. Ran smoothly, no indication of a problem so I looked at the clutch area, The lever has a large nick

out of one side, has moved to the left somewhat and is also bent. Experimentation showed that when you pull the clutch lever in fully, it is fouling something on the flywheel, Bad but even worse is the fact that there is now virtually no arm movement left to actually operate the clutch. Obviously a major strip down is needed to discover what has gone wrong. I decided to pack up early, enjoy a leisurely dinner with a bottle of wine and leave the whole matter for another day.

After an hours patient disassembly I finally managed to get the gearbox out of the bike to inspect the damage, I also removed the head and barrel so that I could check whether the crankshaft had moved. The damage seems to be limited to the bent and chewed clutch operating arm which can be seen in the picture above. Looking at the crankshaft through the top of the crankcase, the amount of clearance looked pretty much identical to what I had set originally. This did eliminate one fear that the multi row main bearing I had used was not suitable for the task. There was nothing else obviously wrong. After much head scratching the only thing I could conclude that the

problem was caused by the drive pins in the flywheel, which seemed to be sticking out much farther than was necessary. I did momentarily consider taking an angle grinder to them but common sense prevailed so I retrieved the extractor tool I made a couple of days ago and pulled the flywheel. The pins are a tight press fit in the flywheel and with the clutch assembled on the bench, it was obvious they only needed to protrude about 20mm. In fact two were about 26mm and the other was 25mm. Careful squeezing in the vice got them all down to 20mm without damaging
