ISDT MZ Project Diary – Started 27th February 2010 – Updated November 2014

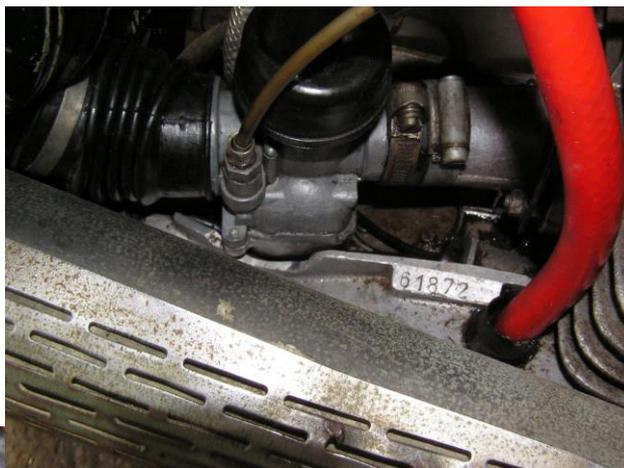
The objective for day 2 was to clean the carb and try to get the bike running. There was an amazing amount of oily dirt and rubbish around the carb and the top of the engine. These items are normally out of sight behind the leathercloth cover and obviously no one had looked or cleaned for a very long time.. The carb is mounted between 2 rubber tubes, one links it to the manifold, the other to the air cleaner. Getting it out was bit tricky as I did not want to damage either rubber mounting and the rubbers were a bit old and stiff. Some heat and lubrication finally had it released. The manifold rubber is only just serviceable but is a simple 32mm id tube. A bit of top hose from the breakers yard will sort that. The air cleaner rubber is a convoluted hose and unobtainable, fortunately it was in excellent condition. The carb once cleaned was also serviceable though it is not of either type mentioned in the spares book. It looks to be from an ETS Trophy sport and is 28mm against an expected 30mm carb. will suffice for now. The only concern were marks on the float that it had rubbed against reassembly I could see that a cut in the sidewall of the LH Not sure if this is standard ISDT bikes or if it was done to this particular carb, Regardless, will need to file the slot a little to clearance.

However, it slight point of bowl indicating something. On slot had been crankcase. feature of accommodate at some time I give better

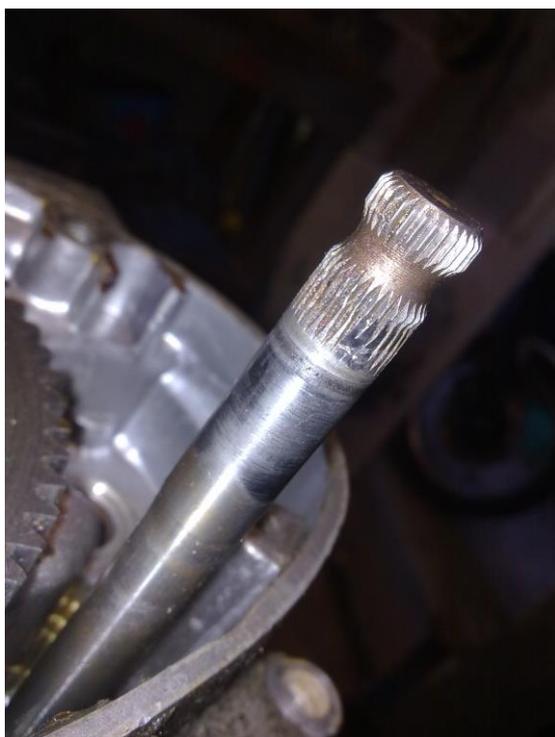
Once the engine was out of the frame I was able to give the frame a good clean – it was remarkably free from rust and will only need a bit of touching up. With the engine on the bench I could start the strip down and very quickly ran into snags. Firstly the drive side

cover was quite difficult to remove; I had to use the hide mallet and some wedges to encourage it to come off. The main sticking point was the gear change shaft. Which was very tight on the hole through the outer cover. At first I thought it was a perished 'O' ring but one was not actually fitted. Then looking at the shaft I could see that the last 50-60mm were rather thicker in diameter than the remainder of the shaft, almost as though a new section had been welded on. Also the slot in the splines is something not previously seen on an MZ engine. Indeed it is not really required as the fixing bolt for the lever does not extend into the shaft at all. It may be something unique to the ISDT motors or I may have a bodged repair, first of many questions.

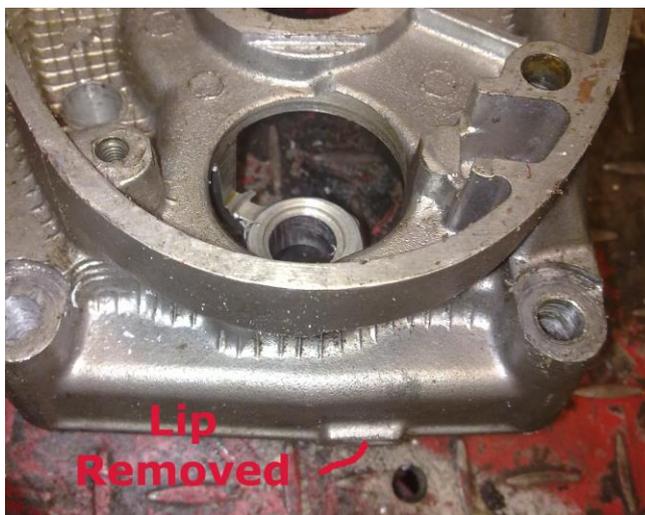
Getting the cases into the frame did give me trouble. I could get either the top or the bottom lined up but not both at the same time. Finding out why proved tedious as the bike was on the floor and I had to crawl around on hands and knees. (Mental note – figure out how to fit a centre stand to the ISDT bike so it can go on the bike lift and stop this crawling around). My initial thought was that the drain plug was fouling the bottom of the frame as it's located differently to the ISDT engine. Eventually I realised it was a projection at the back of the crank case causing the problem. I am not sure what purpose this lip serves unless it to provide something to hit when separating the crankcases. With the proper tool this is not needed and in any event the ISDT motor does not have this lip.

A short session with the hacksaw and a file removed the bulk of the lip after which the engine would go fully into the frame and nothing else now fouled though getting the drain plug out may be a struggle. The picture shows the case after the lip was removed. Pleasingly, the top bolt now lined up perfectly and could be screwed in easily by hand. The bottom bolt was binding, it could have been forced in but I decided to remove the cases and open out the bottom hole to 10.25mm which solved the problem. The next stage was to re-insert the steel tube, and try the crankcases one final time. The top bolt was a little stiffer this time but not enough to worry about so I left the top hole at 10mm. One other helpful factor was that the rubber rear chain tubes fitted the Supa5 crankcase extension perfectly. A relief as I half expected this to be a problem; it was when I fitted a Supa5 engine to an ES250 Trophy.

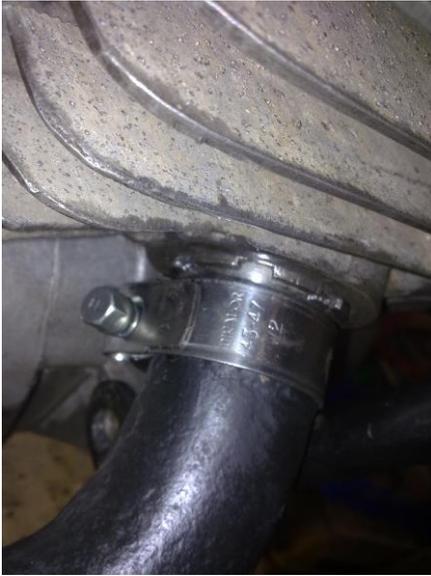
Overnight I decided to build the Supa5 engine completely standard rather than use the ISDT top end. Though it will look a bit odd with the toast rack head at least its 'honest' and will save a further strip when the ISDT motor is ready to be re-installed. This meant removing the engine from the frame so that the rebuild could be completed on the bench. Not a difficult or particularly lengthy job and within half an hour it was back in the frame fully assembled. One further task was necessary however. The ISDT exhaust pipe fits on a stub rather than being held in the head by a screwed collar like the later models. The stub in the ISDT barrel was well corroded in and risked damage to get it out so I had to make a replacement out of an old screwed collar and a piece of old exhaust pipe. The end result is partly shown in the photo (most of it is now in the barrel or under the exhaust pipe). I was then able to fit the exhaust system which to my relief still lined up correctly and overall looks

much better with the new tail can and s/s clip at the front. Next was the messy job I always hate, fitting the rear chain. This time it all went together quite easily and the rubbers fitted the Supa5 crankcase perfectly unlike trying to fit a Supa5 motor in the ES250 frame. I noted that the chain was well worn and will have to be replaced shortly. I will have to check up the spec as it's a different size to the normal MZ chains and may not be a standard size. Last technical job was to fit the Powerdynamo electrics which I managed to make a complete mess of initially. It all seemed to go on ok but sparks were noticeably absent. I went through the whole process again but could find nothing obvious wrong. I even fitted an additional earth wire from the motor. Finally I realised that I had wired up the connector plug incorrectly. It is a 4 socket plug with only three wires and I had put one wire in the wrong socket. I must have a blank spot with this connector as I have done it more than once.

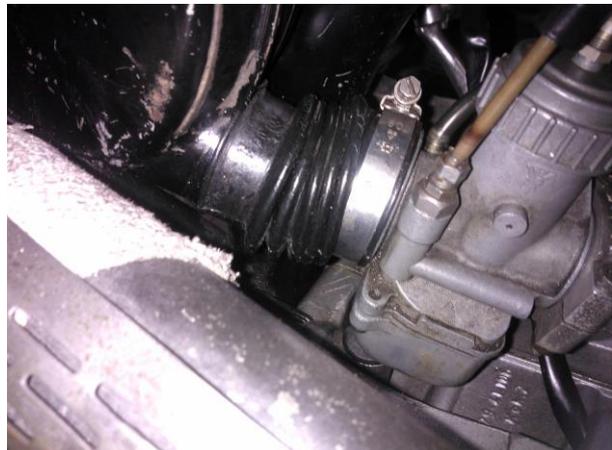
No sign of the powder coating so I cannot rebuild the headlight unit yet. So I tackled the carburettor and air cleaner issues. Stripping the carb to replace the main jet and give it a checkover was easy enough. Finding the correct 135 main jet was tedious as I had everything but this size in my spares tin. In the end I had to strip several spare carbs before finding the right jet. What I took out was a 145 so it would have been far too rich and smokey. All was not wasted however as I found a couple of 130 main jets which I will need for the ETZ300 once I can get it in the garage and on the bike lift.

Next task was to panel beat the air cleaner

to allow it to rotate and line up with the bellmouth. I ground of the welded ridge in the area I needed to indent as this would have made it hard to bend. After that it was just a question of a little tapping followed by a trial assembly until it lined up ok. The final result can be seen. Some blu-tac to seal the slight gap and a coat of black paint to stop rust finished the job. When the bike has a full frame makeover, I will have the indent welded up properly and then powder coated. For now it cannot be seen behind the canvas skirt anyway. I also put a couple of self tappers in the end of the exhaust can to stop the cone from falling out. It was pretty tight but this engine has no rubber mounting and makes a lot of back pressure so better to be safe than sorry. The bike now starts easily and is a bit quieter now that the air cleaner is fitted, just the headlamp to go and then I can road test it.

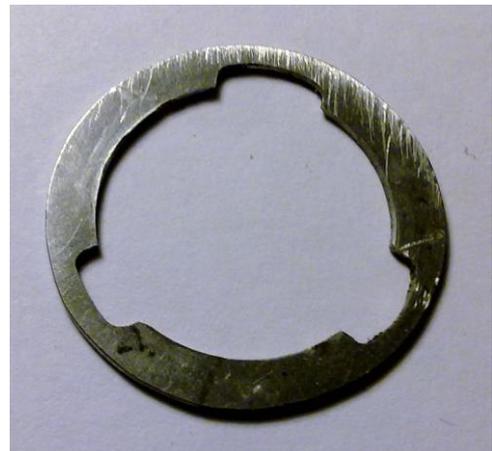
Regarding the original engine, I have not really made a lot more progress. I have ordered some new bearings and seals and a set of piston rings, I found I had all the necessary gaskets already in stock which was helpful. I had what may be a good idea concerning the gearbox shim and bought a 22mm external circlip for the grand sum of 50p which with some carfeul grinding down to the external edges now fits alongside the original circlip. It was exactly 1mm wide, the same as the broken shim so all the end float on the driven gears has now gone and in theory everything should work. I am a bit concerned that the original circlip is now fulfilling the role of thrust washer and I want to discuss this further with an engineer friend before doing a final rebuild. As far as I can see there is not actually a significant end thrust and the gearbox always functioned perfectly well even with the broken washer once you had managed to get it into gear. In fact I do wonder if I could have simply rebuilt it without replacing the washer at all. I may well try a temporary rebuild of just the gearbox assembly to see if I can actually rebuild it and how well it works. Having the inspection cover on the top of the crankcase means it is easy to see what is going on.

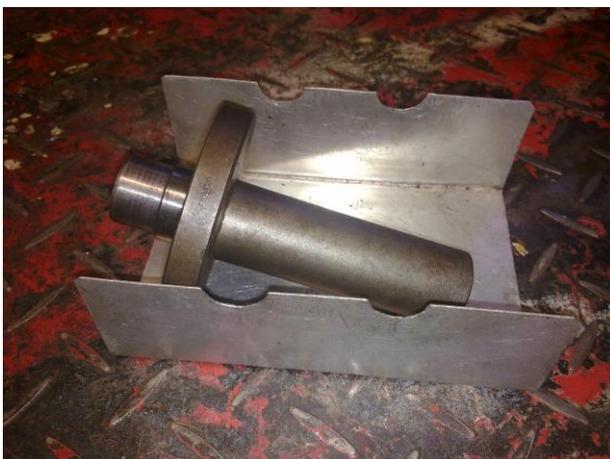
Assembly starts by cleaning and warming the LH crankcase halves to replace the 6203 and 6204 gearbox bearings and the 6305 main bearing (C3 fit though my old ones were not marked as to fit). The gearbox bearings are retained by circlips so do not forget them. The main bearing has to be pushed firmly against a retaining circlip leaving room for the oil seal which is inserted until it is flush with the crankcase wall. Both main bearings on these engines are lubricated by gear oil so are isolated from the crankshaft/flywheels. Be aware that these motors use seals 10mm wide which were originally metal bodied. MZ changed to 7mm seals for the TS motor and though these could probably be used they would need a 3mm packing piece. I would strongly suggest using 10mm seals which seem to be still widely available.

I am lucky in owning the genuine MZ tool to locate the oil seal. If you don't have it then make sure you enter it square and use something to spread the pressure over a wide area as you tap it in - an old 6305 bearing would do. To insert the crankshaft without damage the factory instruct you to use the seal insertion tool (heated in the oven first) to warm up the inner track of the 6305 main bearing and I was able to do this. If you don't have such a tool then just warm up the whole crankcase assembly to about 80 degrees C and the crank will go in quite

easily (especially if you put in in the fridge overnight first). DO NOT heat the bearing centre with a flame and don't use an oven temperature above 100 degrees C for anything with a bearing installed to avoid any chance of losing temper in the bearing steel.

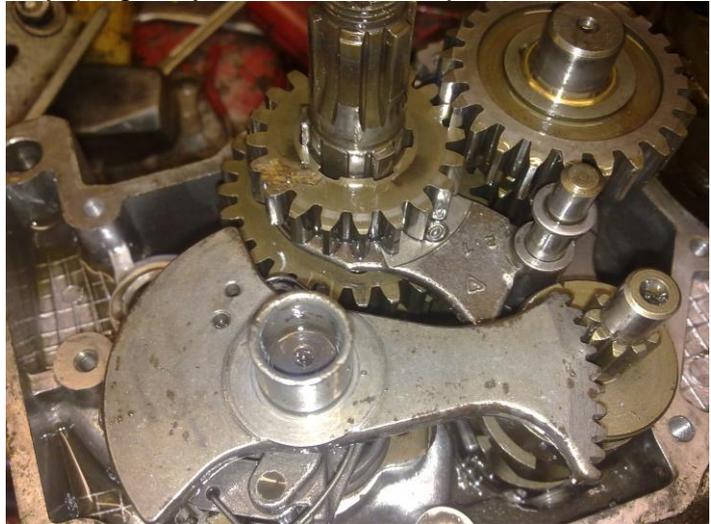
Though it looks daunting, you will find that there is only one way to assemble the selectors and gears. As a clue, the 2.7 selector will be facing the RH crankcase and the selector with a central guide for the drum goes in the middle when correctly assembled.

Another clue – assuming my gearbox is standard there will be a small mark on the outer edge of the selector drum (see picture right). Line this up initially with the mark slightly to the left of the selector shaft as this is very close to the neutral position.

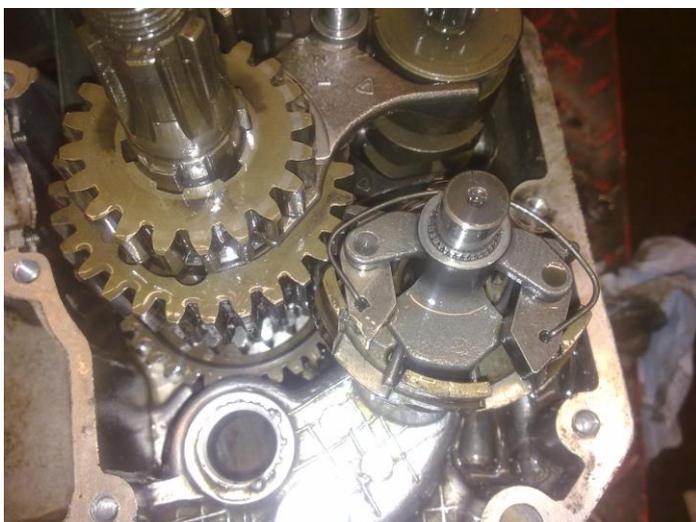
Now fit the primary drive cover of the engine, it will help if you remove the rubber O ring

which seals the gear shaft as this should be replaced anyway but in the interim makes the next stage a little easier. The reason for fitting the cover is to provide support for the gear lever shaft which otherwise wobbles around like a jelly and is very difficult to keep in line when fitting the RH crankcase. This is something I found out the hard way and not mentioned in any manuals I have read. You don't need to fit any of the primary drive bits for now, just the outer cover. You can now fit the gearchange shaft and its spring loaded pawls, make sure the return spring is

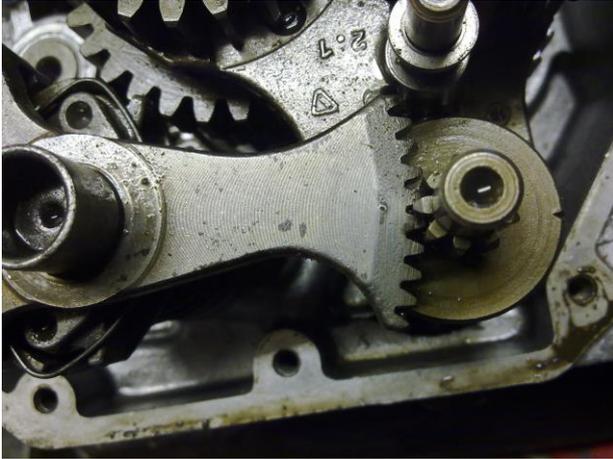
Next stage is timing the gear change. If you look very carefully, you will see on the selector arm a small dot between the middle teeth. Now look at the selector drum and you will find

that one of the teeth has been ground down slightly more than the other, its easy to miss but on my box there was small nick on the opposite diameter of the outer drum (mentioned above) which was in the 3 o'clock position when the ground tooth was in the correct position to line up with the dot on the selector arm. The picture shows how it finished up for me. *Do not try to time it in the neutral position as the selector arm will foul the RH crankcase when you try to fit it as the bottom part of the arm actually protrudes slightly into the drain hole.*

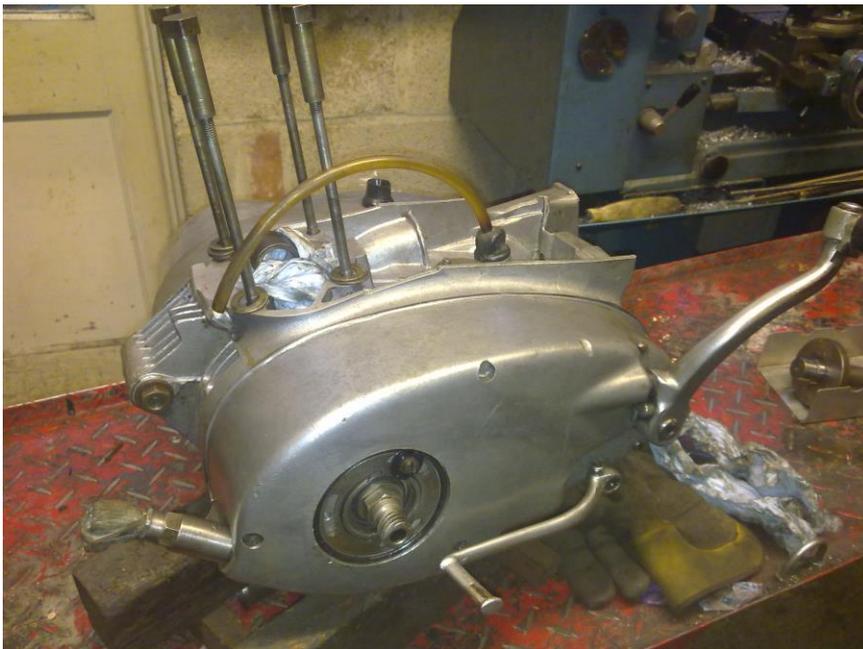
to fit the outer cover; remember to fit a gear shaft O ring. On my engine when dismantled there was no curved (belleville?) washer between the thrust washer and the clutch body so I fitted a new one as the G5 spares book shows it in place. . My motor seemed to run perfectly well without it but it must have contributed a lot to primary drive rattle.

The picture shows the motor as currently assembled. Top end awaiting some new rings before rebuild.
