Project Diary – 1973 MZ ES250/2 – UOY76M – Started May 2018

Concluded - Tuesday 15th January 2019

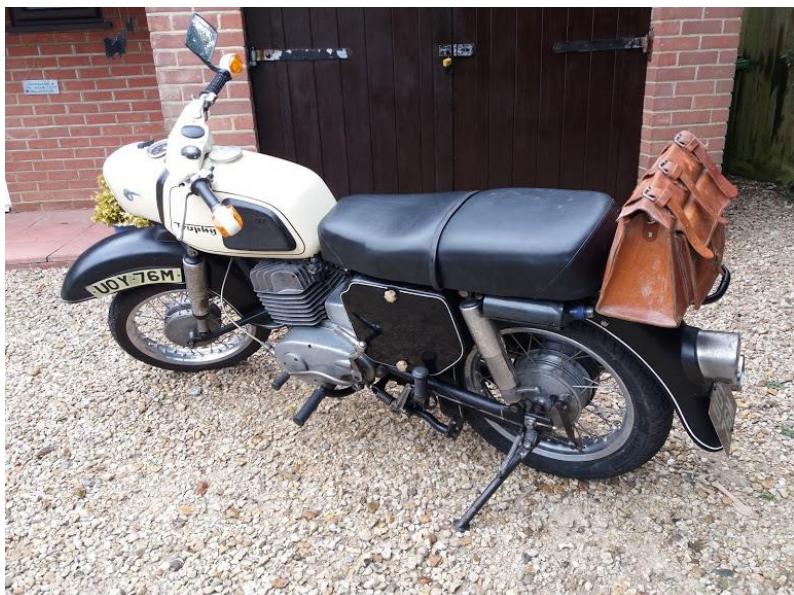
One very trivial change has made a big difference. The Trophy throttle linkage is inside the handlebar and the action has always seemed very slow requiring a second handful to get full throttle. This is one of the reasons why I always felt this engine was a bit tired and gutless. Yesterday I took all the slack out of the cable and the bike feels much livelier. The throttle opens more quickly and did not seem to need the second handful to reach a good cruising speed. I had been planning to replace the original engine but the spare fitted now performs very well so I think I will defer the job until something serious goes wrong. However, it does still leak oil and I am struggling to find where it is coming from

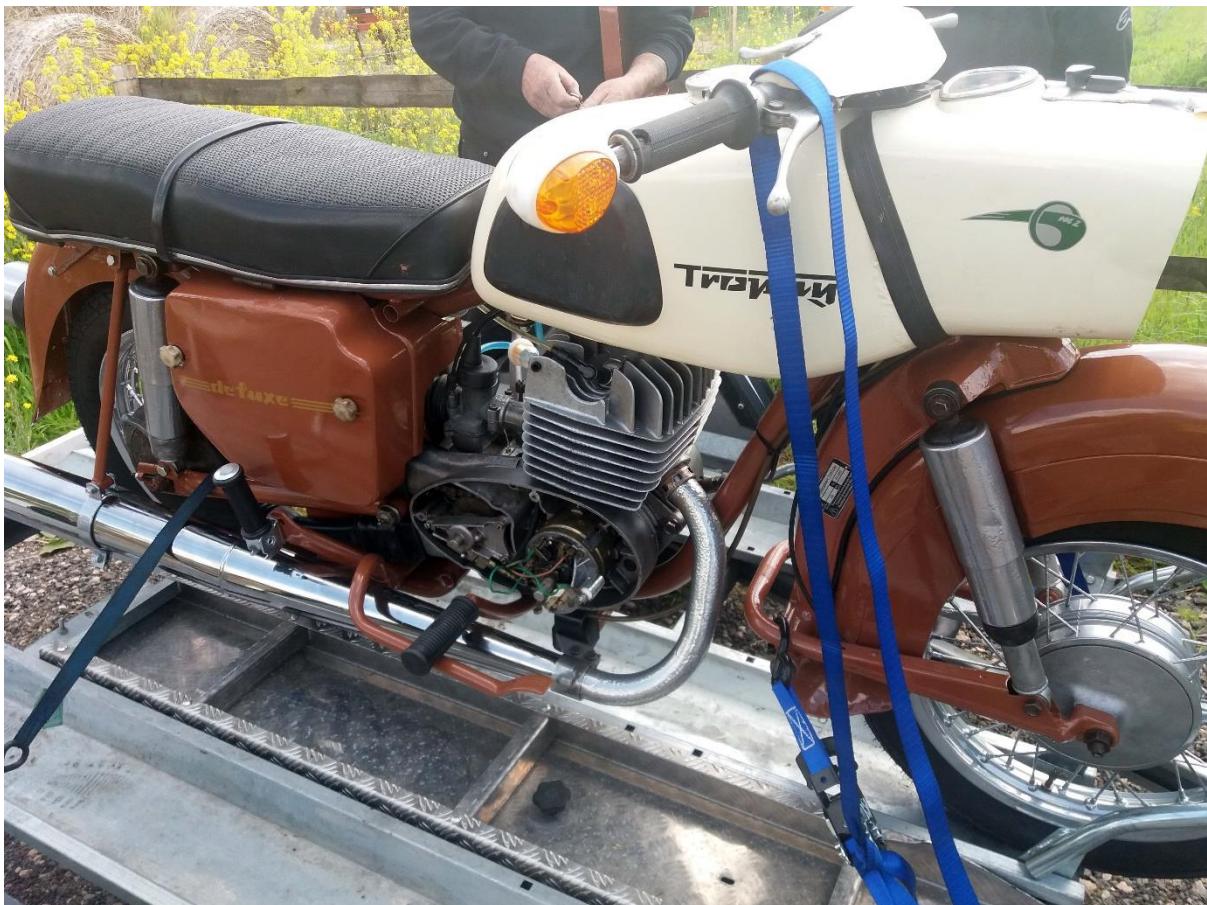
Funnily enough Mick Taylor turned up at Ham with his recently purchased ES250/2. It was an incomplete mess when he bought it (makes me realise how lucky I am with my project bike) so he has done well to get it the state it is now in. Not sure the colour scheme does anything for me but it has been well done for sure. Interestingly he chose to have the wheels blasted and powder coated, the whole lot , rim, spokes and hub. They were done in a shiny paint that looks just like chrome. Tempting, but I think I would prefer to keep my au natural as far as rim and hub are concerned and use s/s spokes. Th ex pipe and shock covers are also done in chrome powder; food for thought?

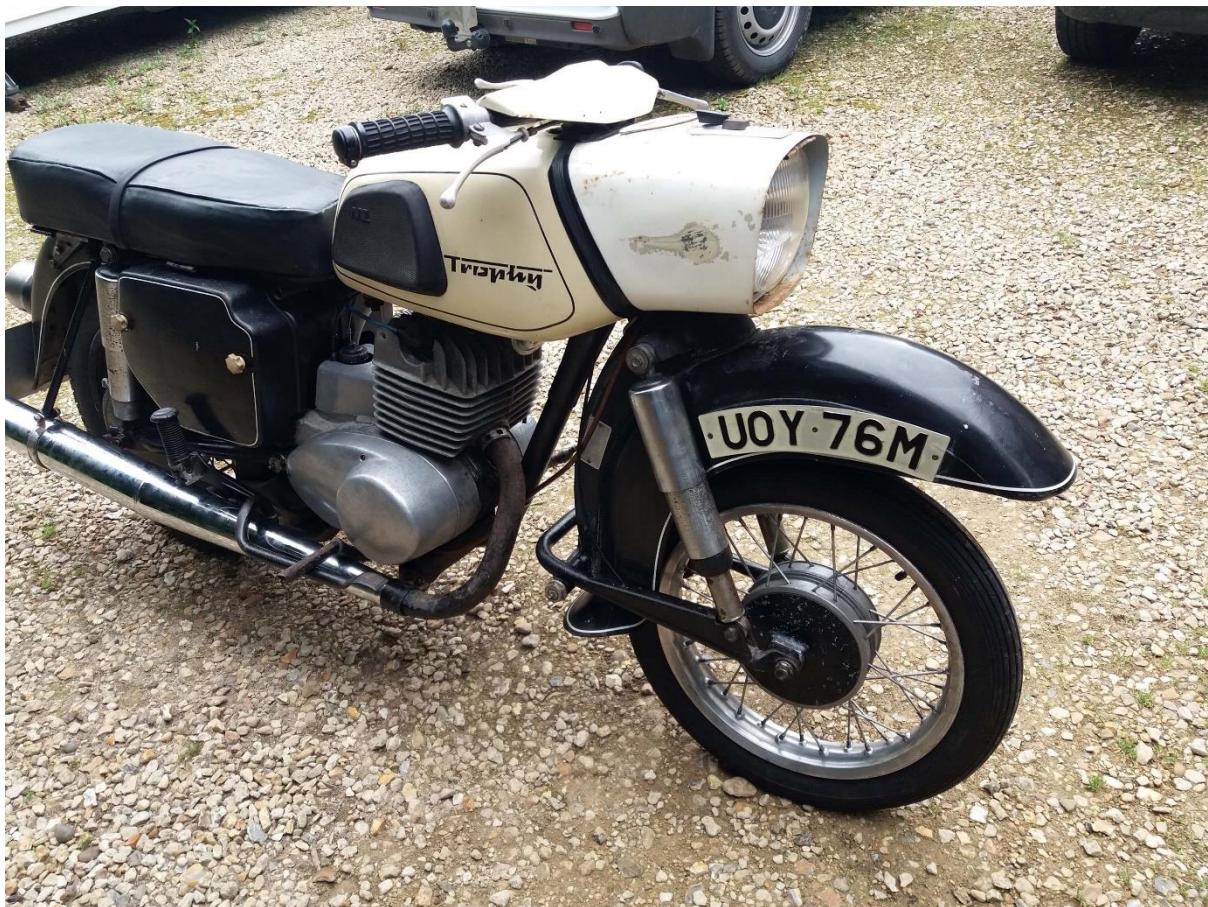
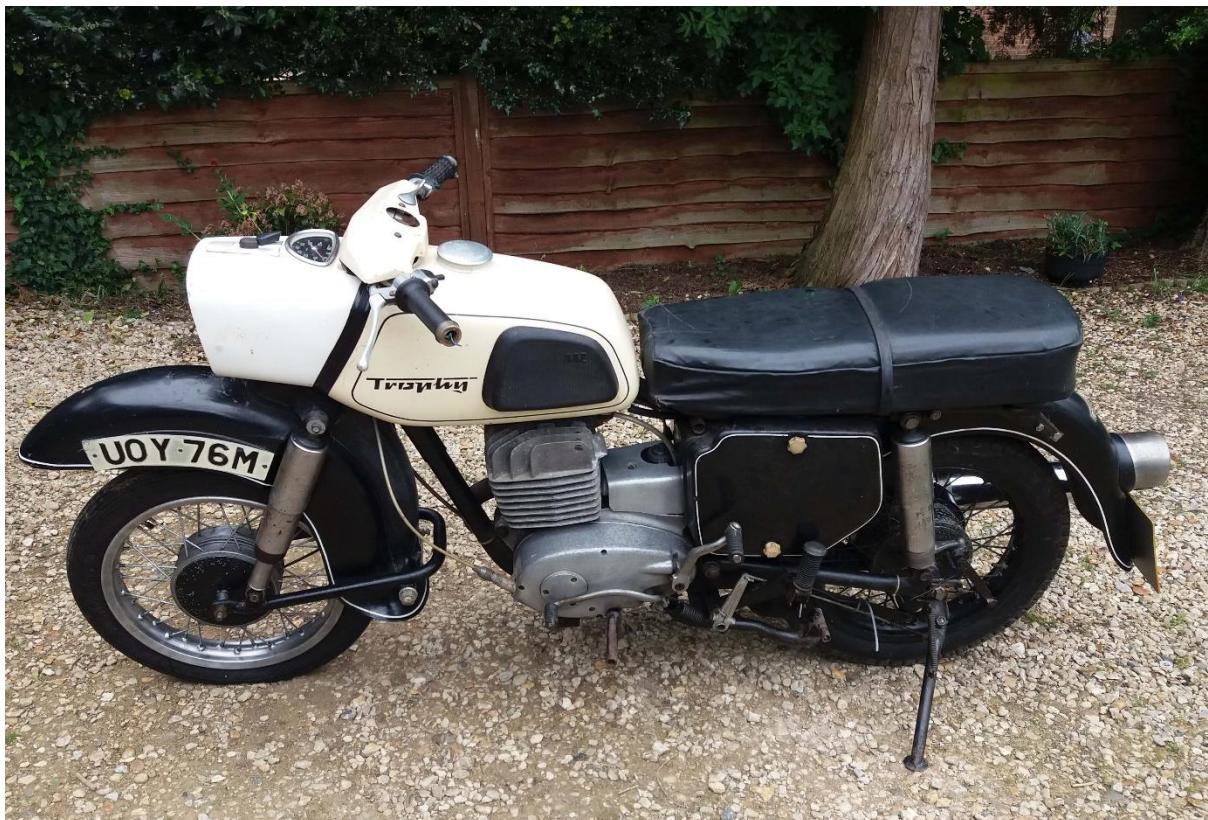
The backward step was the fitting of what appeared to be a considerably straighter footrest bar. It turned out to be bent as well (but differently) and fouls the silencer as well as the left footrest pointing backwards. Ho hum. I wheeled it outside for a photo session and a couple of the shots are below. Actually it doesn't look too bad and I think will look ok as an oily rag machine. Some of the obvious bits missing like the footrest rubbers and the headlamp surround are in the spares box along with a new exhaust pipe.

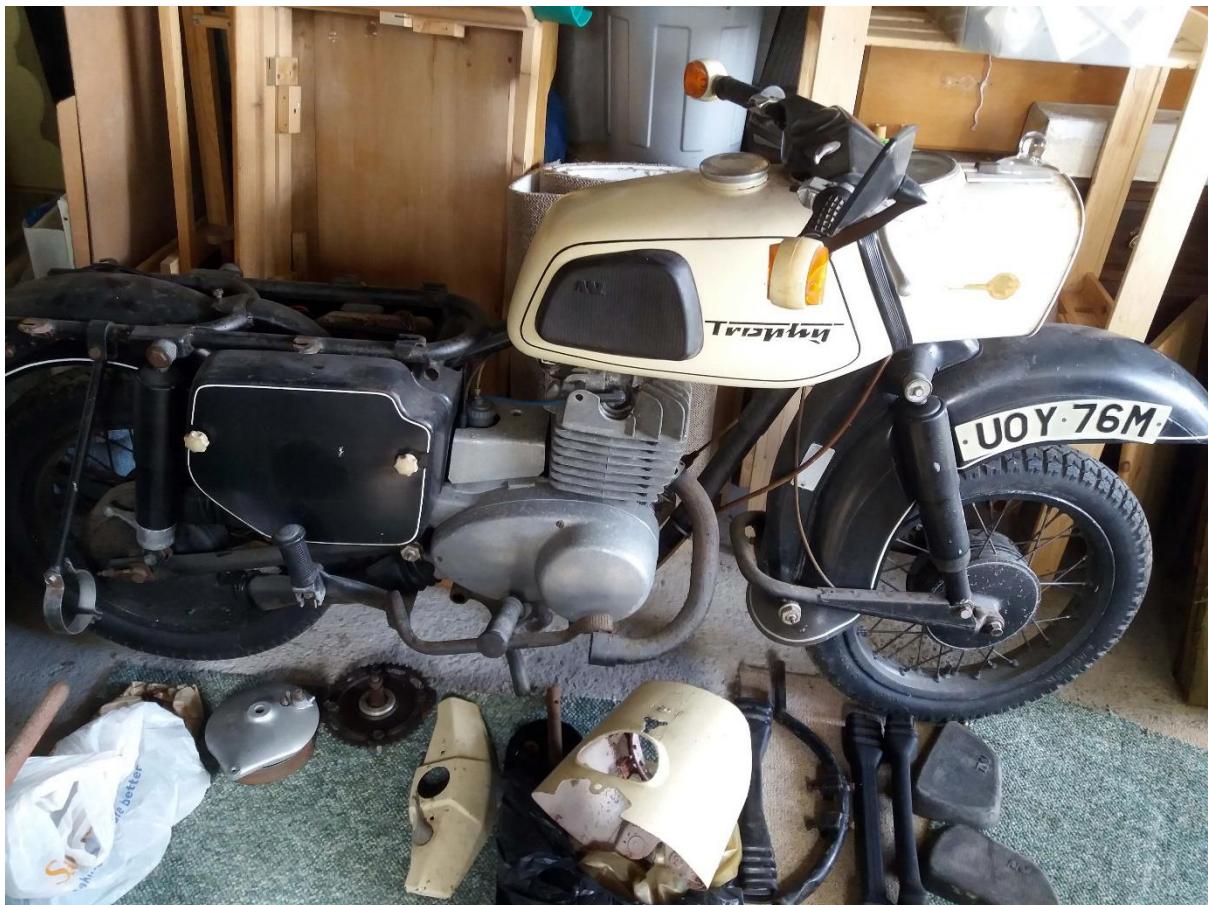
I have known about this bike for several years. It belonged to John Rayment who lives at Batheaston. He bought it in 2001 as a restoration project which was never started despite regular nagging from me. Eventually he decided he was never going to restore the bike and offered it to me. A deal was done and it is now in my garage along with some useful new parts:

The bike is pretty much complete and has a recorded mileage of 38k, the only obvious non original part is the cylinder head which is from the later TS250 4spd. Cosmetically its pretty challenged possibly not even up to oily rag condition. My intention is leave it that way only dealing with serious rust and any mechanical deficiencies.
