The BK350 Saga

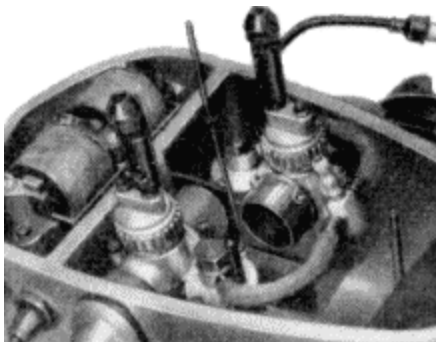
Today the carbs were partially stripped and a few minor things sorted out. Both needles were in the lowest position which may be significant but for the moment I have set them per the manual at groove 3. The pilot airscrew on inside was nearly correct at 2 turns out

the other was about 4 turns out. Both are now set to 2 ½ turns out also per the manual. The throttle slide arrangement is quite unique and not just because of the flat slides. The slide is actually operated by a rod which terminates in a special housing which also locates the throttle cable. This complex arrangement is needed to allow the top cover to be removed and replaced easily. There are also buttons built into the top cover to

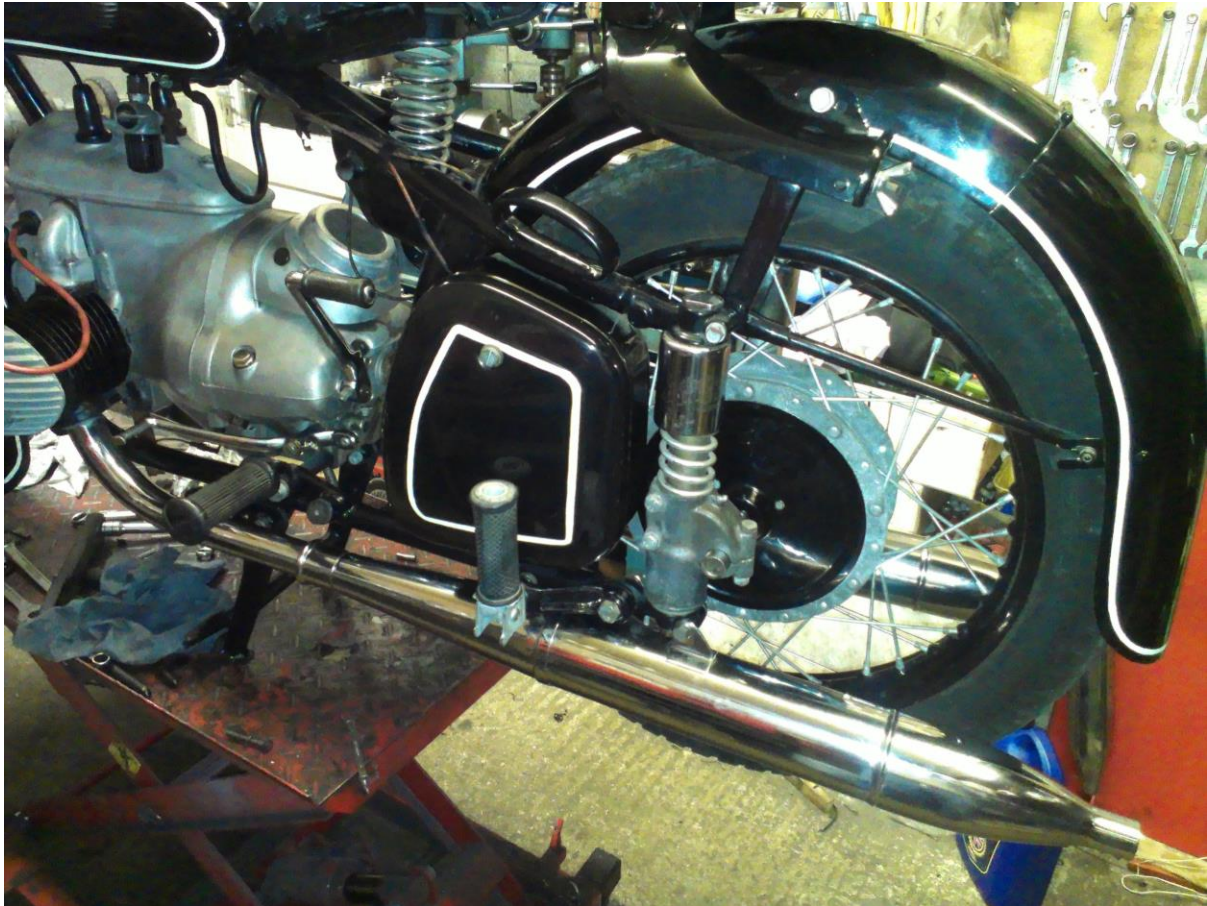
was simply impossible to get the system to align properly. I had more success with the near side and found a combination of pipe and silencer which aligned pretty well spot on. Out of interest, I tried the original off-side exhaust pipe with a new silencer and still no joy, the

pipe was too short and in any event it was pretty shoddy. More out of desperation than anything else, I tried the near side exhaust pipe and to my surprise it was a perfect fit with the new silencer. Moreover, this pipe was a stainless steel item which I was able to polish up quite well. At some time I will have to re-visit the off-side exhaust for now I have a pretty good looking system.

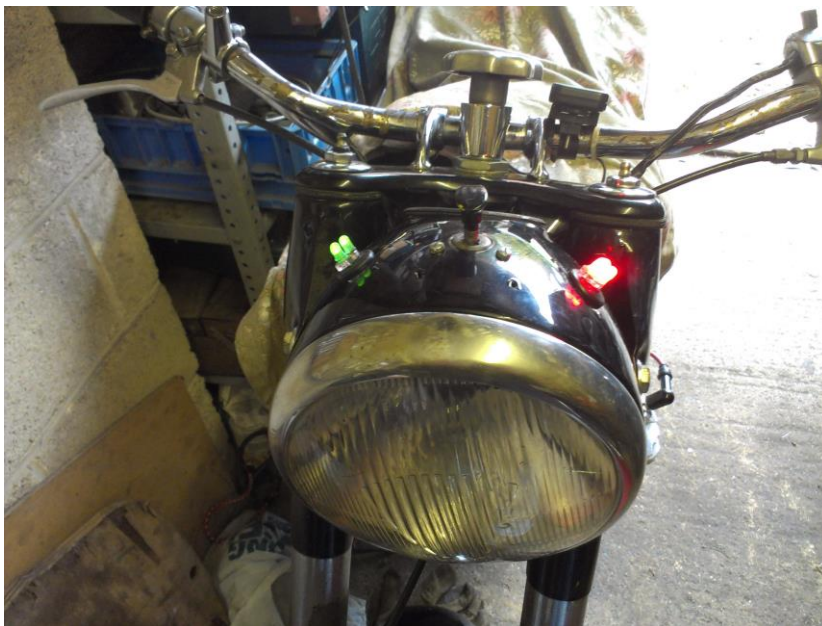
DVLA have confirmed that the bike is to be inspected on Tuesday 6th November at 10:15 so another trip to Bristol but at least this time I should come away with a registration number and a tax disk. Pondering on the temporary warning lights that are currently fitted, I figured out a way to improve them. Two led bulbs were made up with tails long enough to connect into the wiring switch and bypassing the special cup bulb holder. The tail wires of the led

assembly were slim enough to pass through the cup holder and a couple of rubber grommets neatly sealed the hole. Not a wonderful job but much neater than my first attempt. The only snag was that in my haste to fit them, I forgot to seal the assembly with araldite to make it waterproof so I will have to partially dismantle them some time. It's not urgent as

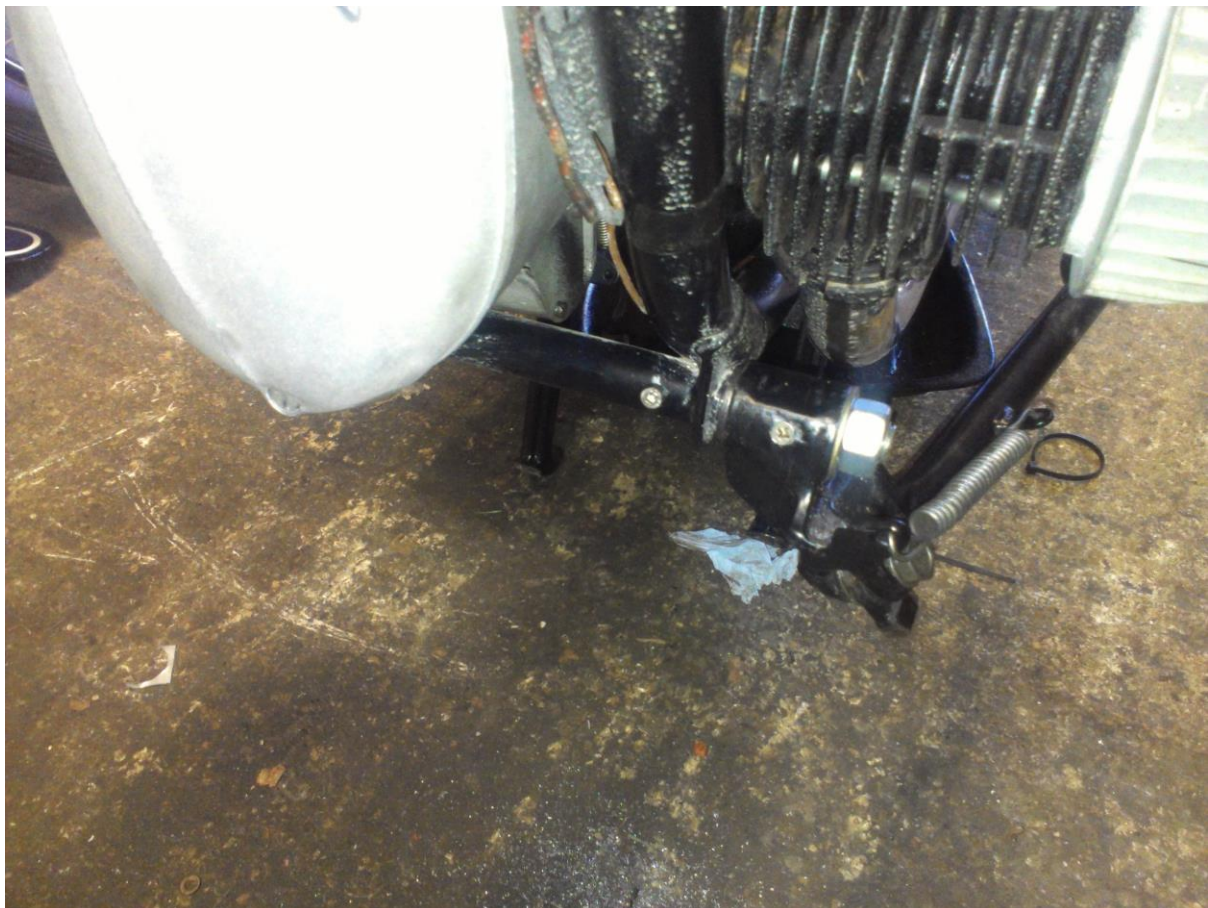
Back at the garage I decided to press on with a few other jobs. I wanted to fit a prop stand as the centre stand is a bit heavy to operate. Research on the internet showed an MZ style rear spindle fitting being used in conjunction with the front lower frame tube. As it happens I did have a spare MZ stand and some 16mm threaded bar. The result is shown in the picture below. To stop the stand turning I drilled a hole in the frame tube which was tapped for a high tensile 5mm set screw and a 5mm hole right through the stand and threaded bar for a high tensile 5mm bolt. Quite a neat result I felt.

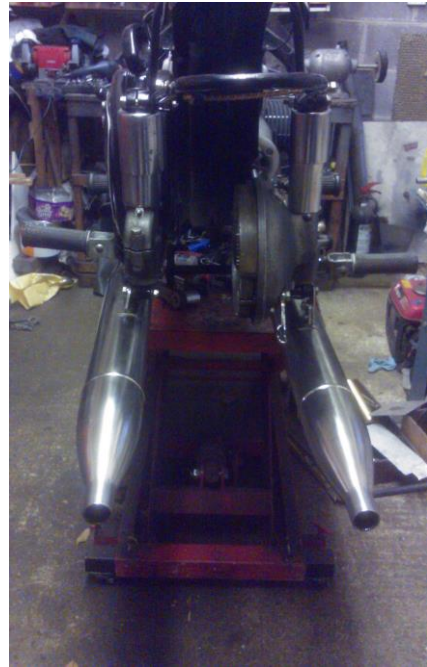
new parts. I was determined this time to use the complete new system but each time I offered it up the result was disappointing. The silencers are identical but the pipes do have a slightly differing bend but whichever side I put them on they did not look right. Eventually I got it all to line up with the mounting holes in the frame but when I looked from the rear the offside silencer was sitting

about 4 inches higher than the nearside. The problem seems to be with the pipes which are not quite the right bend but though the system is new I don't know from where it was purchased so I cannot take issue with the supplier. In the end I decided the safest thing to do was make up an extension plate for the offside silencer mounting which drops the silencer to the same level as the nearside. That way, to anyone following behind they will look level though if you look closely you can see that they slope towards the pipes at differing angles. Raising the nearside (which I would have preferred) was not an option as the silencer is already very close to the frame on this side. I even tried making up a thick gasket for the exhaust manifold to push the pipe down lower but this did not work and really left too little thread to make a secure fixing. I guess German after-market stuff is just as bad as the stuff we often get for British bikes.
