Simson AWO 425 Restoration Diary

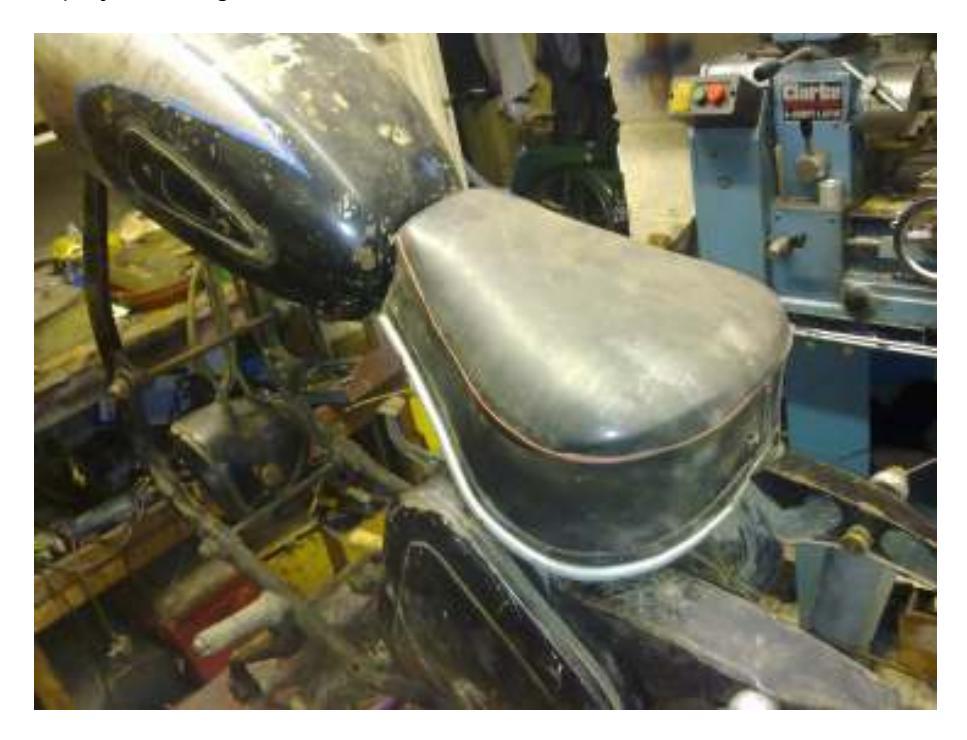
Back home the first job was to unpack all the boxes and do a quick assessment of what we had and perhaps more particularly what we didn't have. On the rolling chassis side the only obvious missing item was the speedo cable. The tank had some brazing around the fixing holes which will need to be tested, there are a couple of dents and the chrome is fairly poor. A more rigorous examination is needed but hopefully it will at least be usable in the short term. There was also signs of welded repairs at various points which suggest that vibration may have been as issue on this bike. However, no show stoppers that I could see. The engine is probably complete but it's in so many bits I have no real way of telling as I have yet to acquire a parts list. I found the broken cam follower and home made push rod Steve had mentioned so they will be an urgent requirement, The cam shaft itself looked fine and all the various bearings I could identify were common metric sizes so they should not be a problem, The crank journals look fine but there is a bit of play in the big end so it might pay to get that sorted sooner rather than later. There were three barrels and two cylinder heads so I should be ok in that respect. Pleasingly, the engine and frame numbers matched. Speedo was present seems to work ok and showed about 36k kms (about 23k miles) no way of knowing if this is correct, probably not given the broken speedo cable. The gearbox thankfully was still complete and seems ok all the gears select via the hand change lever, the foot change lever is still proving elusive. Final act of the day was to examine the paperwork which was somewhat limited. The original Hungarian log book showing the date of first registration as 17th May 2011. The frame number matched that on the bike and the VIN plate also showed 1960 as year of manufacture. There were also a few Hungarian vehicle tax receipts, the most recent dated 1979. The only other paper work was the Customs receipt showing duty paid in 1999 and a workshop manual. This was in Hungarian so apart from the pictures of limited use at present. Below is a picture of the frame etc set up on my work bench ready for the project to begin:

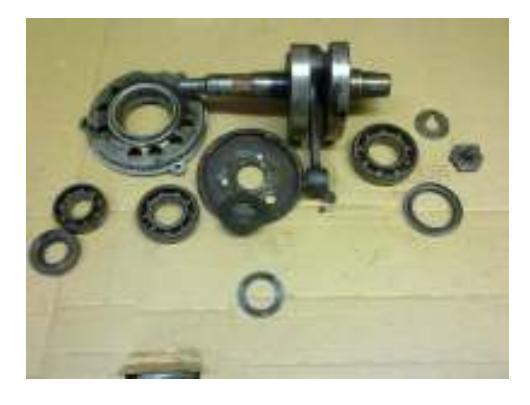
Quite a lot of progress today. I have joined <u>http://www.awoforum.de/</u> on the web which seems to have over a 1000 members. Though the membership is predominantly based in Germany and the site is mainly in German, with the help of Google translate I have been able to read some of the posts and through them found useful documentation and established a few links with other members. They have very kindly suggested that I post my questions (of which I will have many) in English as many members are fluent in that language but I will try to upgrade my language skills as well. I have submitted a photograph of the various parts that I believe comprise my crankshaft assembly and am waiting to hear if I am missing any items.

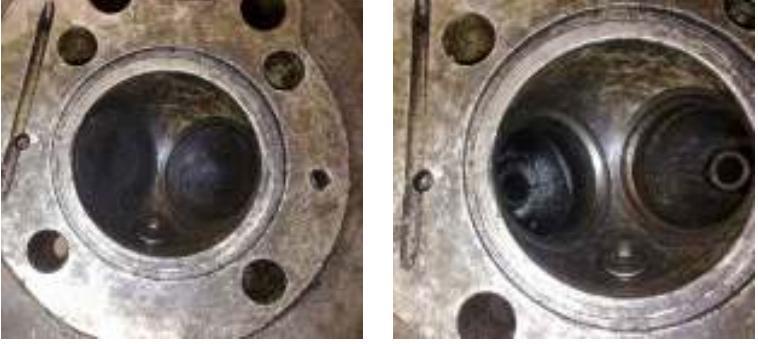
Cannot believe that it is over a week since I updated the diary and I am having difficulty remembering exactly what I have done with respect to the AWO in that time. A lot of it has been research on the internet trying to find information and parts. Most of the bits I need are available but irritatingly not all from a single source. To add to the problem, some sellers will not post outside Germany and/or do not take Paypal making paying for items a bit tricky. On the positive side, I have taken the cylinder head to a local engineering shop. They will be able to fit new valve guides and valves. They can also replace the valve seats but it is not clear yet if this is needed. I am consulting the AWO Forum on the subject. Pictures of the head with and without valves below:

The big question is whether the deep recess of the inlet seat is a design feature or the result of 50 years abuse. I have already established that the exhaust valve is incorrect the one fitted is 36mm whereas it should be 34mm.

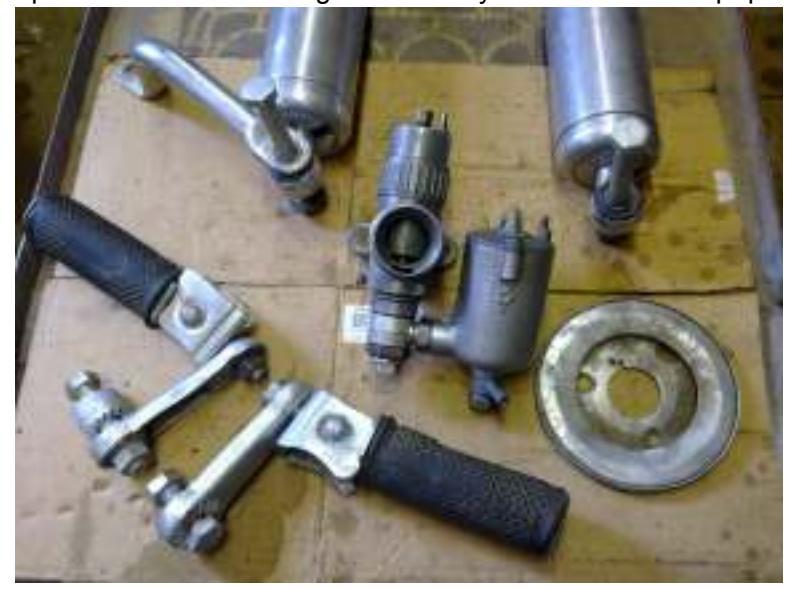
shows. These centrifugal filters collect an amazing amount of crud from the oil and it packs tight setting like concrete. The picture also shows the carb which cleaned up well and the rear struts which have also cleaned up pretty well, the heads of the bolts were also plated. I have now surveyed everything and have a pretty good idea of the bits I need to firstly complete the rolling chassis and secondly to rebuild the engine. About to spend money rather than time I fancy.

I have also made up a tool which I hope will enable me to fit and centre the clutch. I will add a picture later. As things were a bit quiet, I also decided to strip and plate the pillion footrest assemblies. I noticed later that you can buy replica footrests for about £17 but at least mine are now shiny and the originals. I also found a complete but very rusty oil thrower on an old crankshaft. After carefully removing it (I had to drill out the retaining ring which was very tight), I spent the best part of an afternoon cleaning it up and then left it soaking overnight in pickling acid. Today I plated the thrower, mainly to stop it going rusty again as clearly paint was not an option for an item running continuously in hot oil. Came up quite well as the photo hopefully

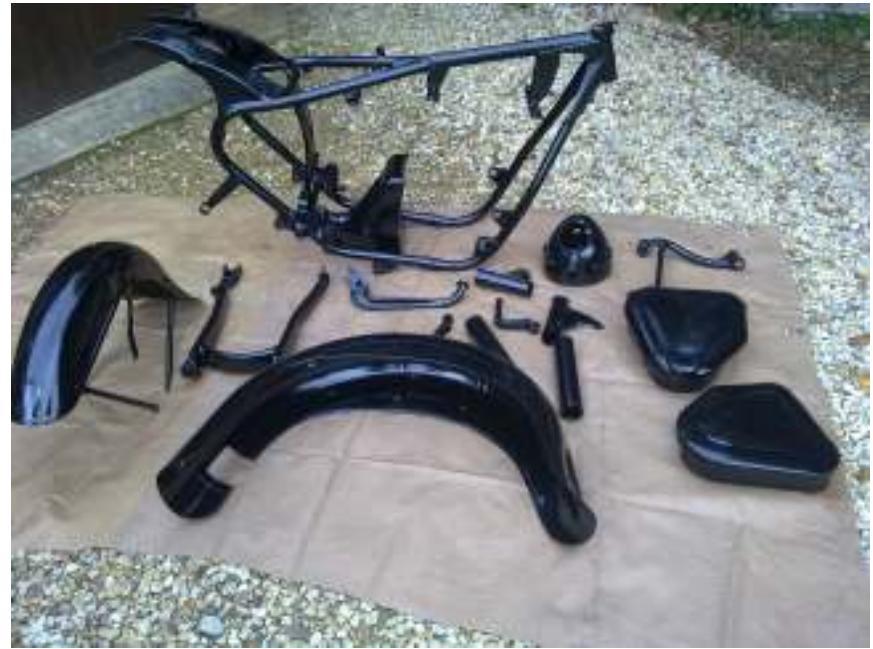
combination of corrosion on the stanchions and an excess of powder on the inside of the shrouds. Powder coating is tough stuff to remove. Eventually, I did get the forks reassembled and it will be much easier next which will not be too far away as they are quite badly worn and bushes /seals etc are in the shopping list coming from Germany. Fitting the mudguard turned into the next challenge, funny it seemed to come off in a simple

What a difference a day makes (well actually two days). The powder coating was available as promised on Friday afternoon and I took the following picture of the parts. I don't think it does justice to the quality of the work and I was delighted with the result. As you can imagine I have spent quite a lot of the last two days putting it all back together. Some parts were quite easy, other gave me some grief. Very first problem was the swinging arm bearings. I thought they were metal and left them in the arm but with the holes sealed to stop the powder getting inside. When I removed the selas. The bushes just fell out. They seem to be made of a composite material which has shrunk in the oven. In the end I had to make up some temporary bushes so that I could carry on with the rebuild. The design is such that I ought to be able to fit the new ones when I can get them. Fitting the airbox, tool & battery boxes and mudguard was pretty straightforward as was the bevel box and rear wheel. At last it was beginning to look like a bike, This was just the softening up stage; reassembling the front forks took nearly a whole day. The steering head assembly went in quite easily, the old headstock bearings are satisfactory for now but I did source new ¼" balls. (why do continental bikes still use imperial measures for some

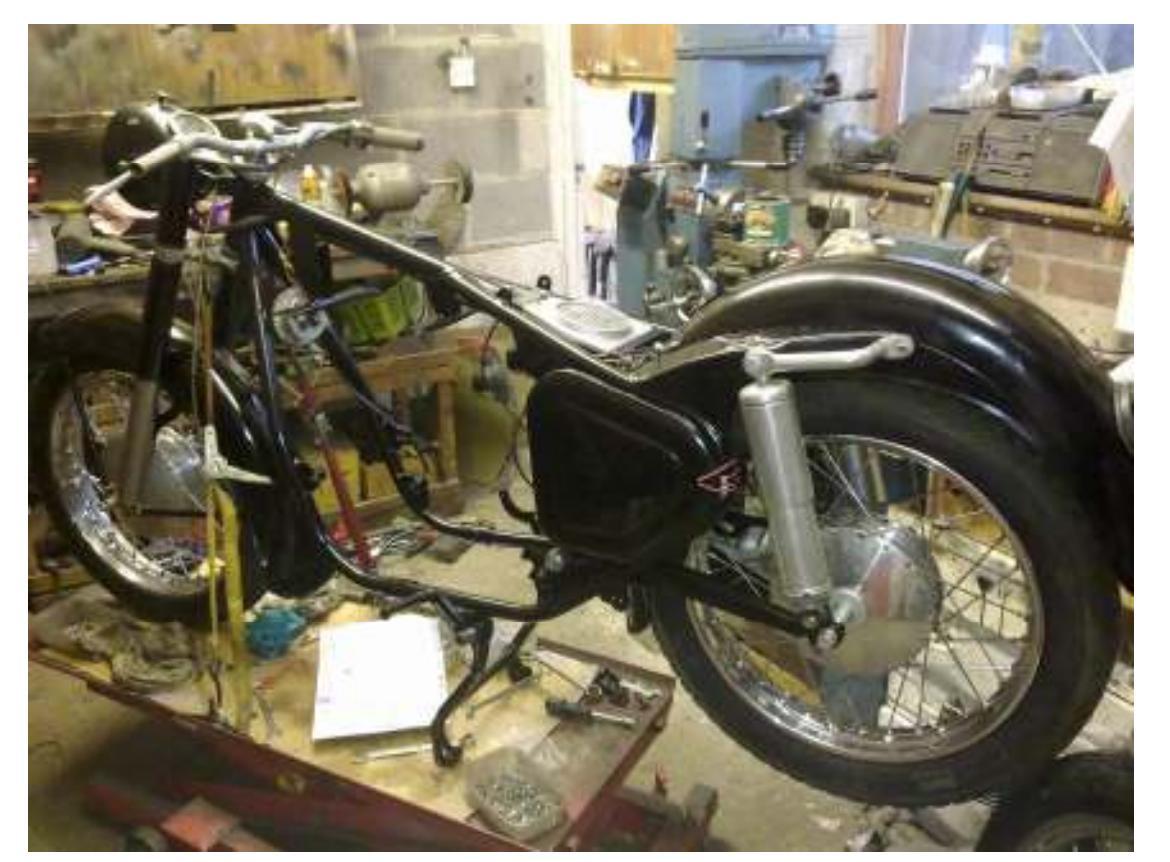
legal in the UK as the rear light lens appears to be orange. The only snag I encountered was trying to fit the headlamp rim. It just will not go on. I was getting a bit tired and irritable so have parked that problem for another day. Still a long way to go but signs of real progress at last.

I decided to fit the wiring harness and associated electrical equipment next. Initially it was difficult to figure out exactly where it should all go but fortunately I had taken some pictures and this jogged the memory. Its actually very neat and apart from round the headstock, most of the wiring runs inside the tinware, Pleasingly my home made loom fitted perfectly and all it needed was the last few connectors once I had trimmed everything to length. I have used the MZ style rear light unit for now as a genuine AWO type is over £40 and I am not sure it would actually be

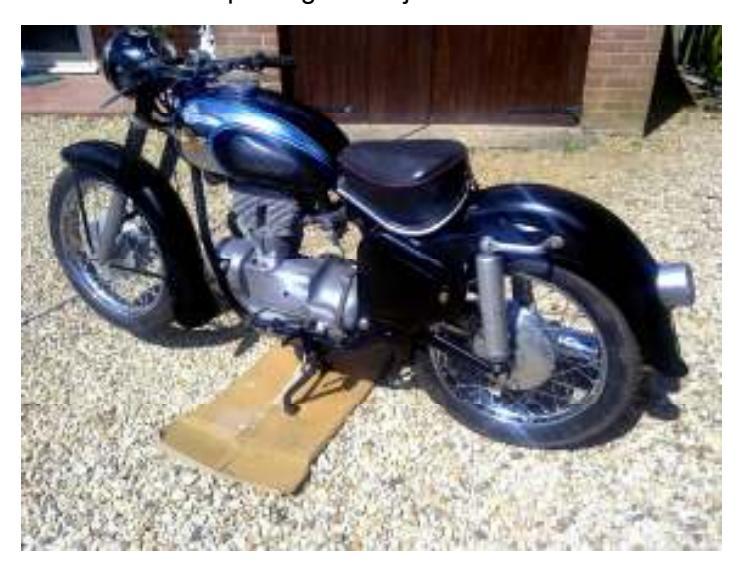
Officer requesting a dating certificate so hopefully I can expect a visit sometime soon. Armed with that and the MoT I can start the process of registering the bike with DVLA. This is how it now looks. I believe the outstanding jobs to be:

- Fit the petrol tank with its tap and plumbing
- Sort out the headlamp rim
- Fit the passenger seat and footrests
- Buy and fit a 6v battery (or borrow one from the MZ more likely)
